Subject: Inspection of Thompson Lake Dam

The Thompson Lake Dam (Maine ID 00133, NatDam ID ME00016) is located at the outlet of Thompson Lake, on Outlet Stream, a tributary of the Little Androscoggin River, in the Town of Oxford (Town), Cumberland County, Maine (Figure 1). The dam was originally installed around 1800, rebuilt in 1863 and modified in 1974. The 1863 dam reportedly raised the natural lake level by 10 feet. Since 1863 the dam was owned by the Robinson Manufacturing Co. The Robinson woolen textile mill was closed in 2004 and the dam ownership was transferred to the Town of Oxford in 2009. The dam has low hazard classification.

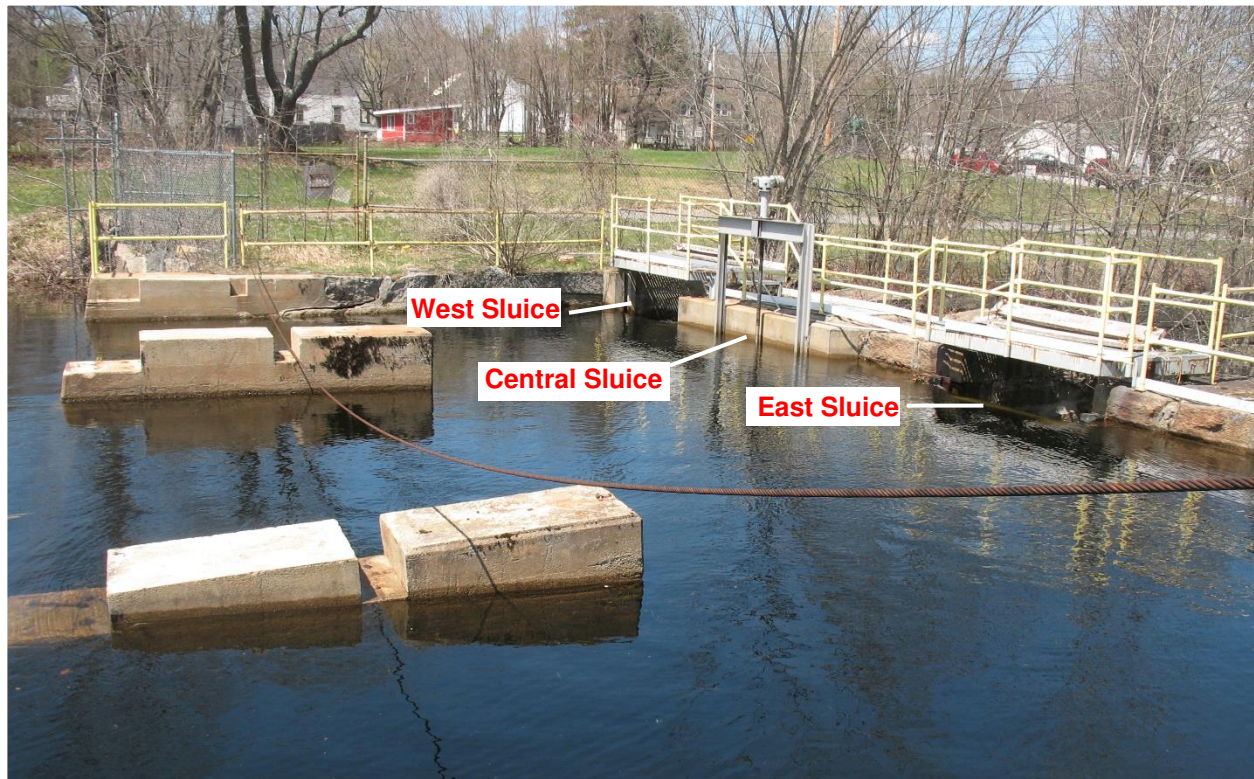
Photo 1. Upstream View of Dam.

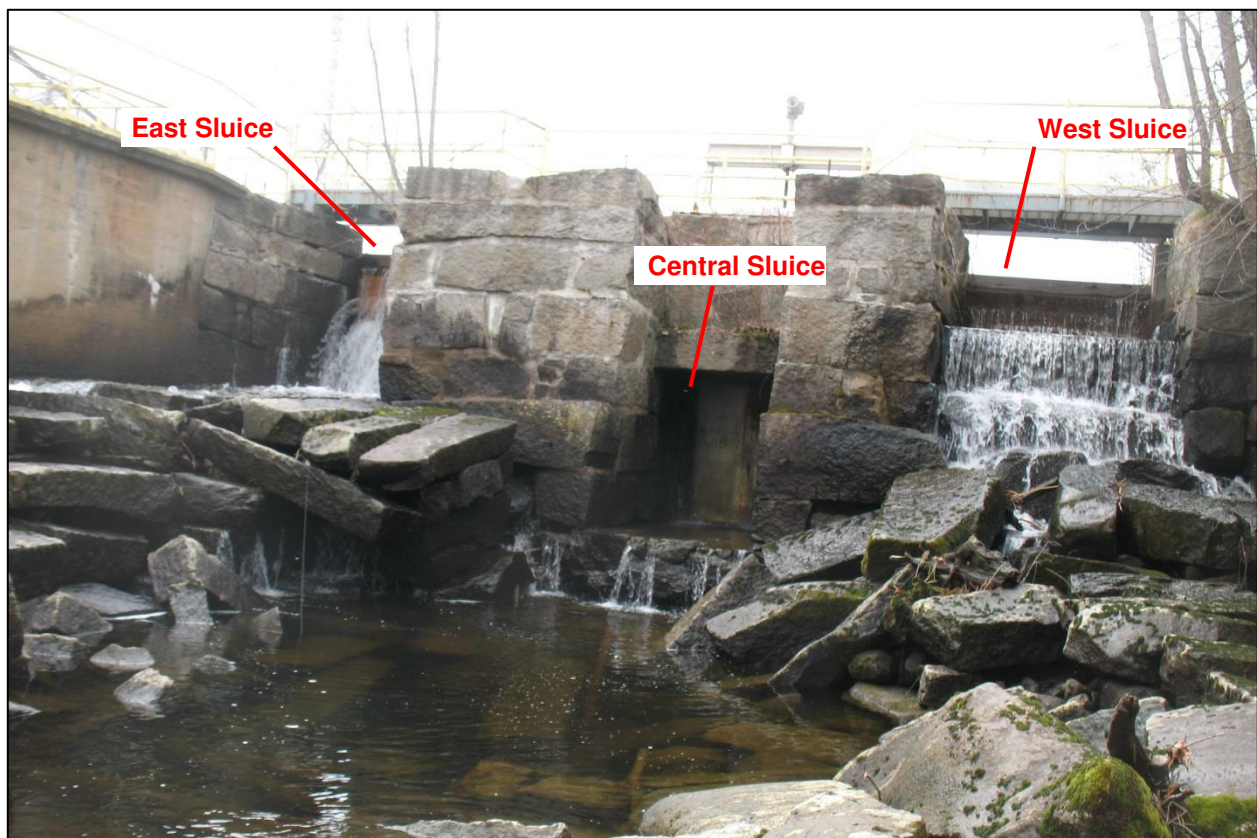
Photo 2. Downstream View of Dam.

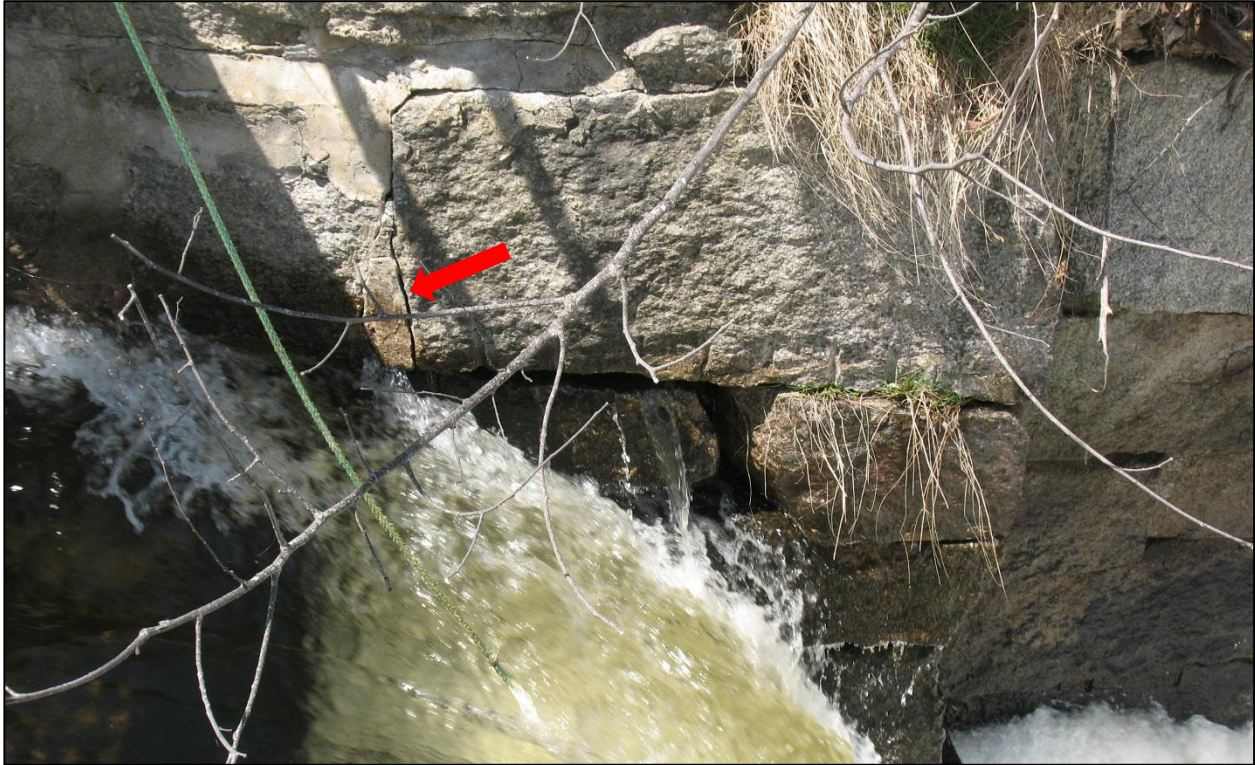
West Sluice. The 7.2-foot wide, 3.6-foot deep west sluice built as a broad-crested overflow weir appeared in operational condition. The left wall of the sluice exhibited wide open joints and mortar missing (Photos 3, 4). One stone block appeared overstressed, cracked but stable, with no signs of movement observed (Photo 3). The right sluice wall contained large voids, cracked stone slab and was leaking moderately, about 1 gallon per minute (gpm) (Photo 5). The sluice opening width was shortened by the 1993 concrete overlay on the left side (Photo 4). This was likely done to accommodate a stoplog guide. With the stoplogs in place (second inspection), the boards were leaking extensively at estimated rate 1-2 cubic feet per second (cfs) or about 500-1,000 gpm (Photos 4, 5). The steel platform spanning the sluice and handrail were quite rusty but solid and safe for foot traffic and stoplog operation (Photo 6).

Photo 3. Left Wall of West Sluice. Note Open Joints, Crack in Masonry, Vegetation.

12. The sluice sidewalls contain a number of large voids and open, leaking and vegetated joints. To protect the masonry from degradation these voids and joints should be cleaned, grouted and sealed. The upstream face leakage entries should be identified and sealed prior to the downstream repair work. This masonry repointing, sealing and repair work should be described and materials and repair methods used documented.

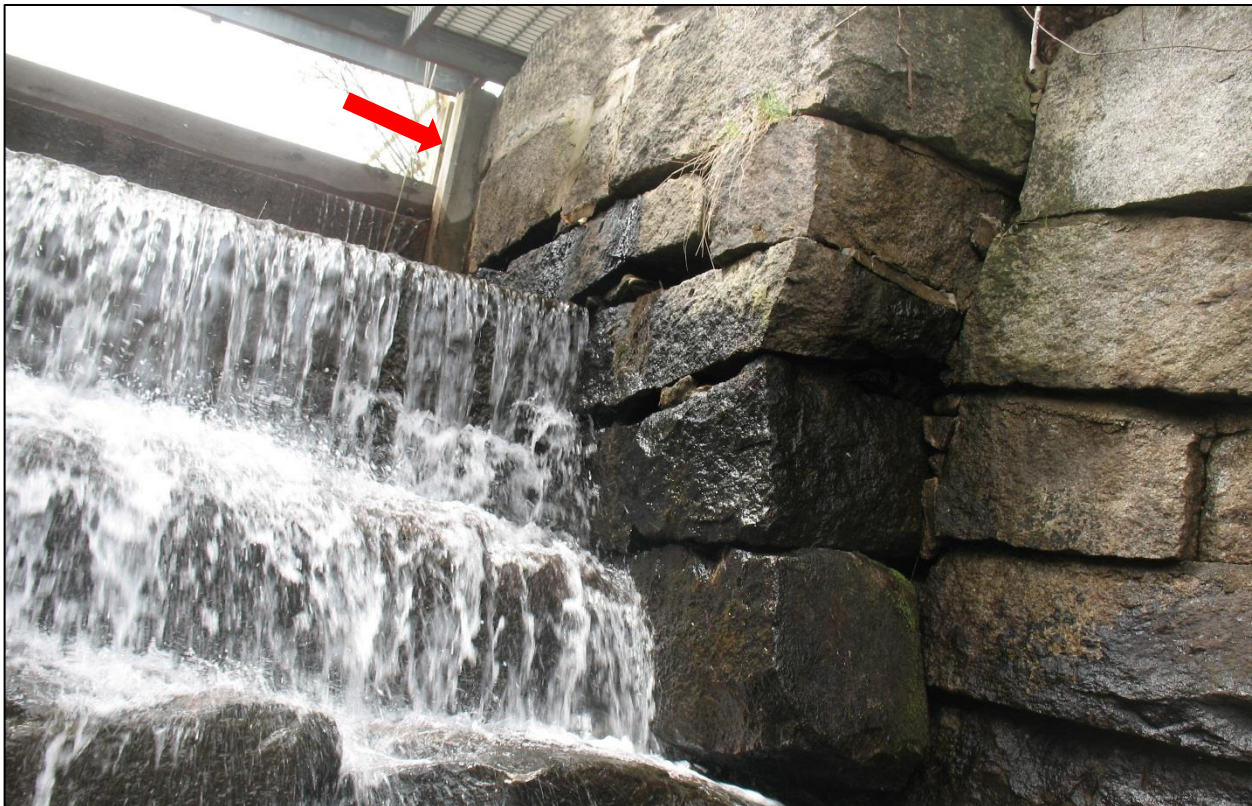
Photo 4. Downstream View of West Sluice: Voids in Masonry, Leaking Stoplogs, 1993 Concrete Overlay (arrow) in Sluice Opening.

8. The removable stoplogs in the east and west sluices are leaking extensively when in place. The leakage could be reduced by replacing the worn stoplogs with new boards and the use of a plastic cover on the waterside. The new boards should fit tightly when stacked.

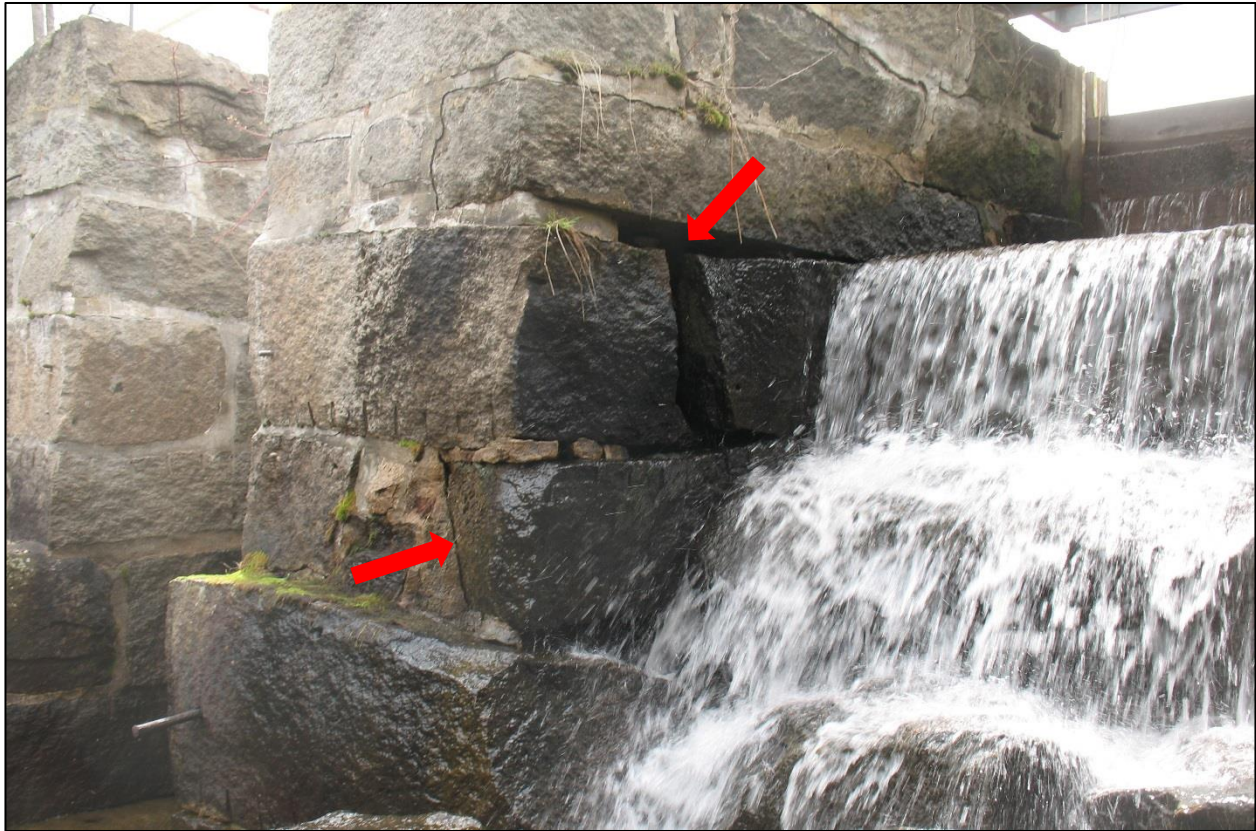
Photo 5. Right Wall of West Sluice. Note Missing Mortar, Large Voids and Crack in Masonry.

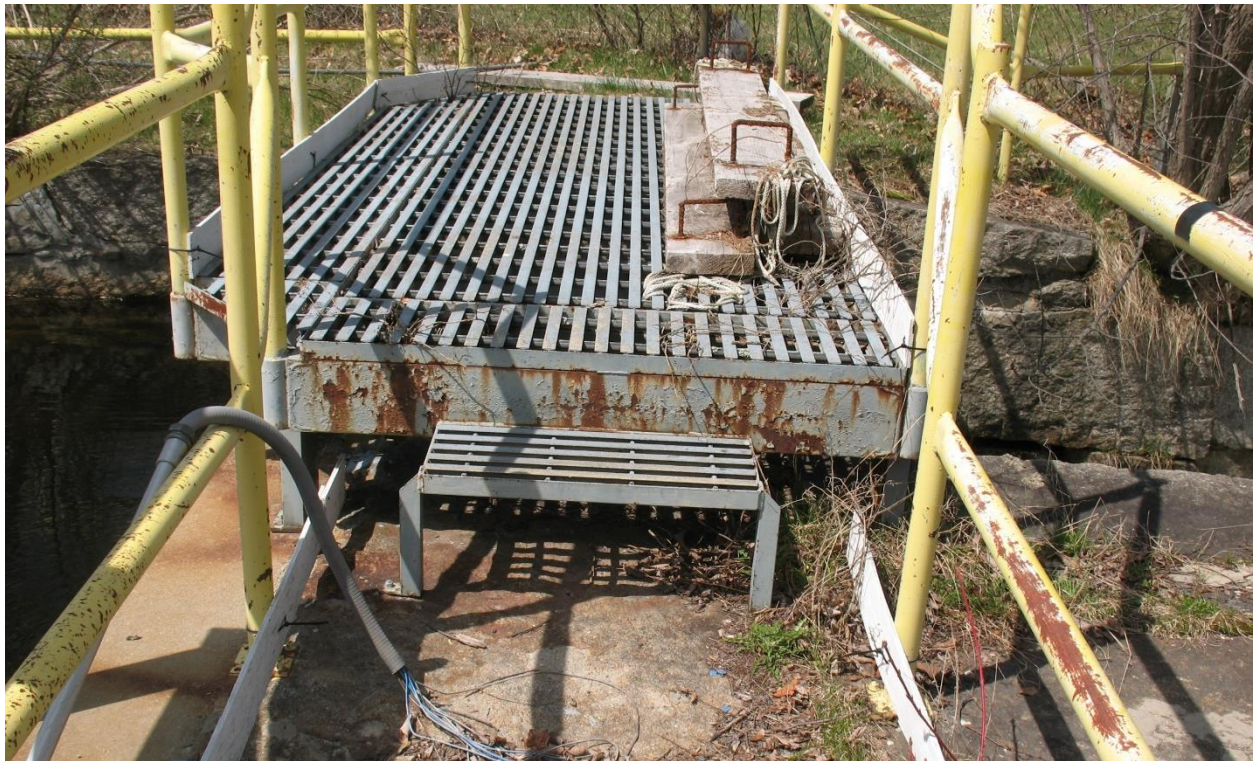
Photo 6. West Sluice Operating Platform.

10. The steel platforms spanning the east and west sluices and handrail on the top of the dam exhibited significant rust and should be repainted. This repair activity should be included in a regular maintenance program.

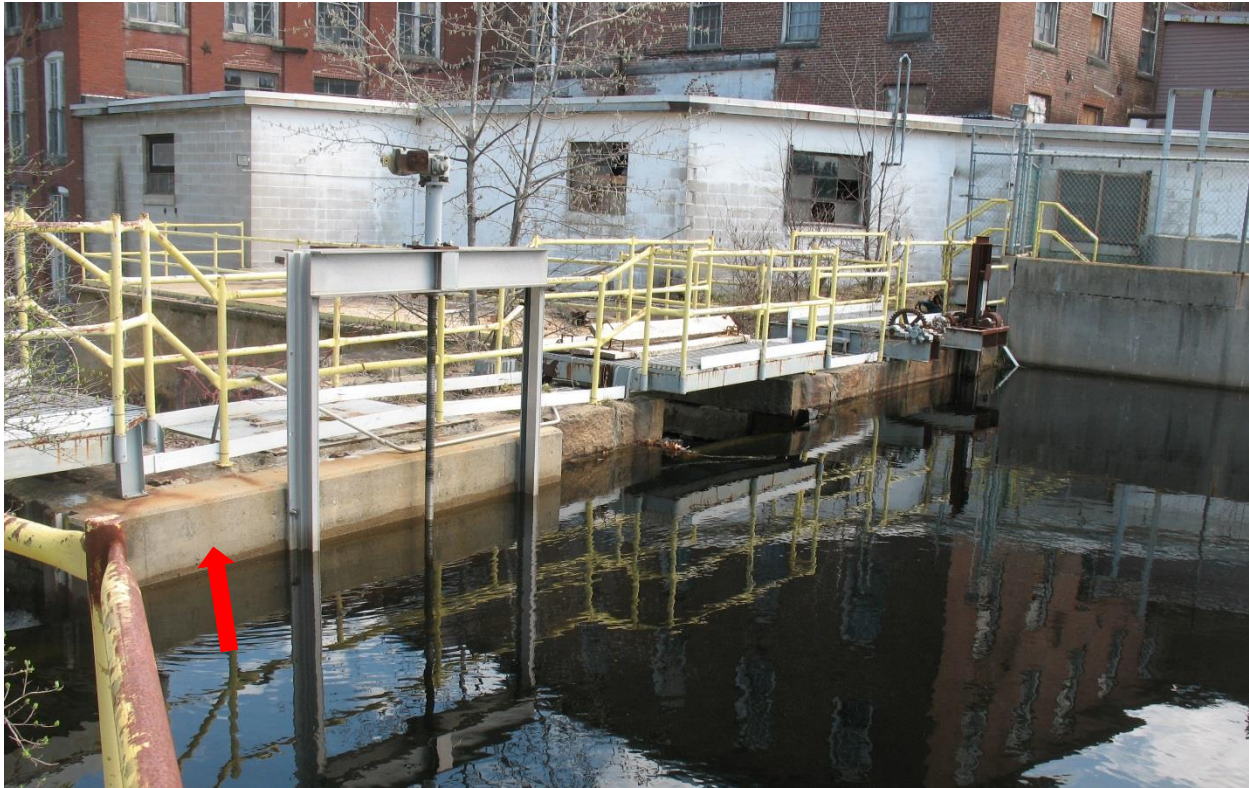
Central Sluice. The central sluice is a low-level outlet containing a slide gate attached to the 1993 concrete overlay. The exposed gate frame and stem appeared in reasonable condition (Photo 7). The gate stem and hoist showed some rust and should be lubricated periodically. The gate was closed and inoperable for some period of time, reportedly, due to the problem with an electrical motor. The gate could be operated manually but at the very slow-moving rate. The gate malfunctioning reduced significantly operating dam capacity to pass excessive flows and created conditions for silt accumulation at the dam.

Photo 7. Upstream View of Central Sluice: Concrete Overlay (arrow), Gate Frame, Operator and Stem Installed in 1993.

5. The slide gate in the central sluice provides over 50 percent of the available dam hydraulic capacity and is currently inoperable. Restoration of operation of the gate should be a priority in reducing the risk of overtopping, enhancing operational flexibility and improving safety of the dam. The gate hoist and stem (observed rusted) should be cleaned and lubricated every 6 to 12 months.

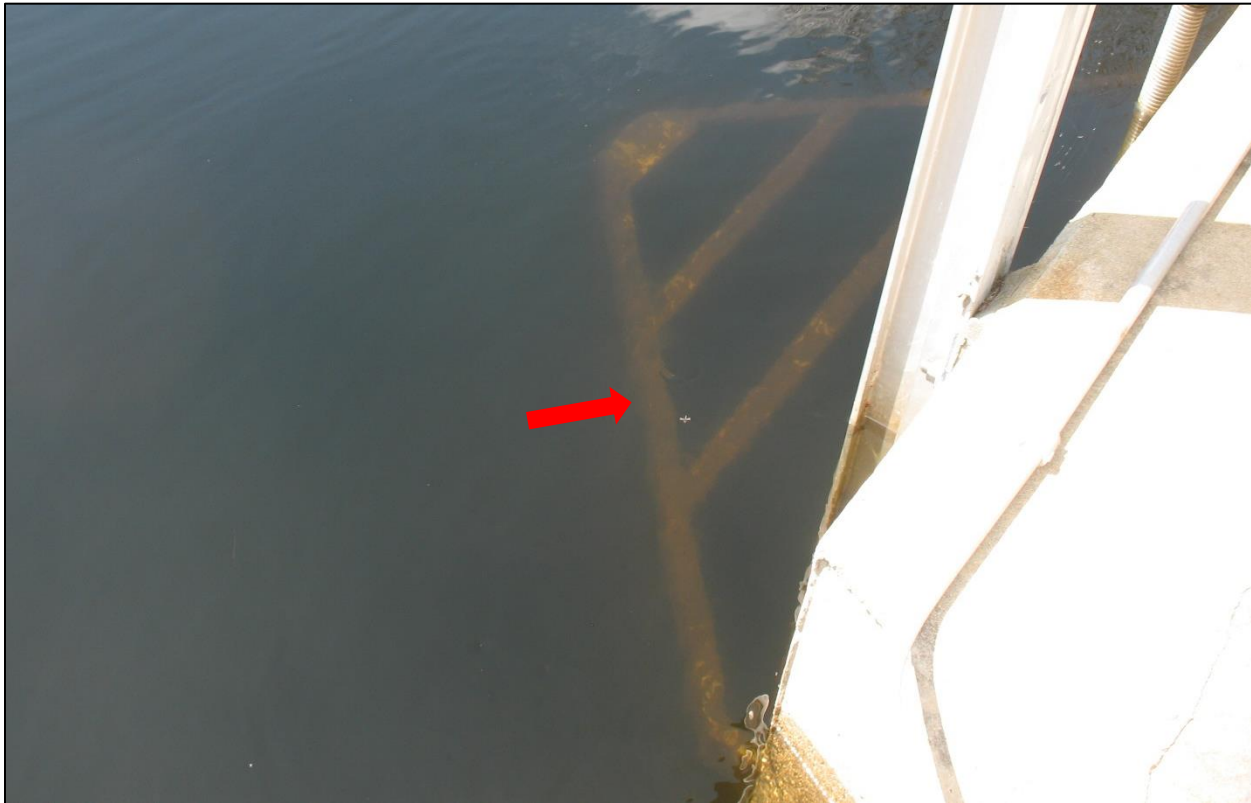
The submerged top of the 2014 gate trashrack observed through 1 to 2 feet of water appeared clean and debris free (Photo 8). However, the amount of debris collected at the deeper areas of the trashrack was unknown.

Photo 8. Central Sluice: Submerged Gate Trashrack Installed in 2014.

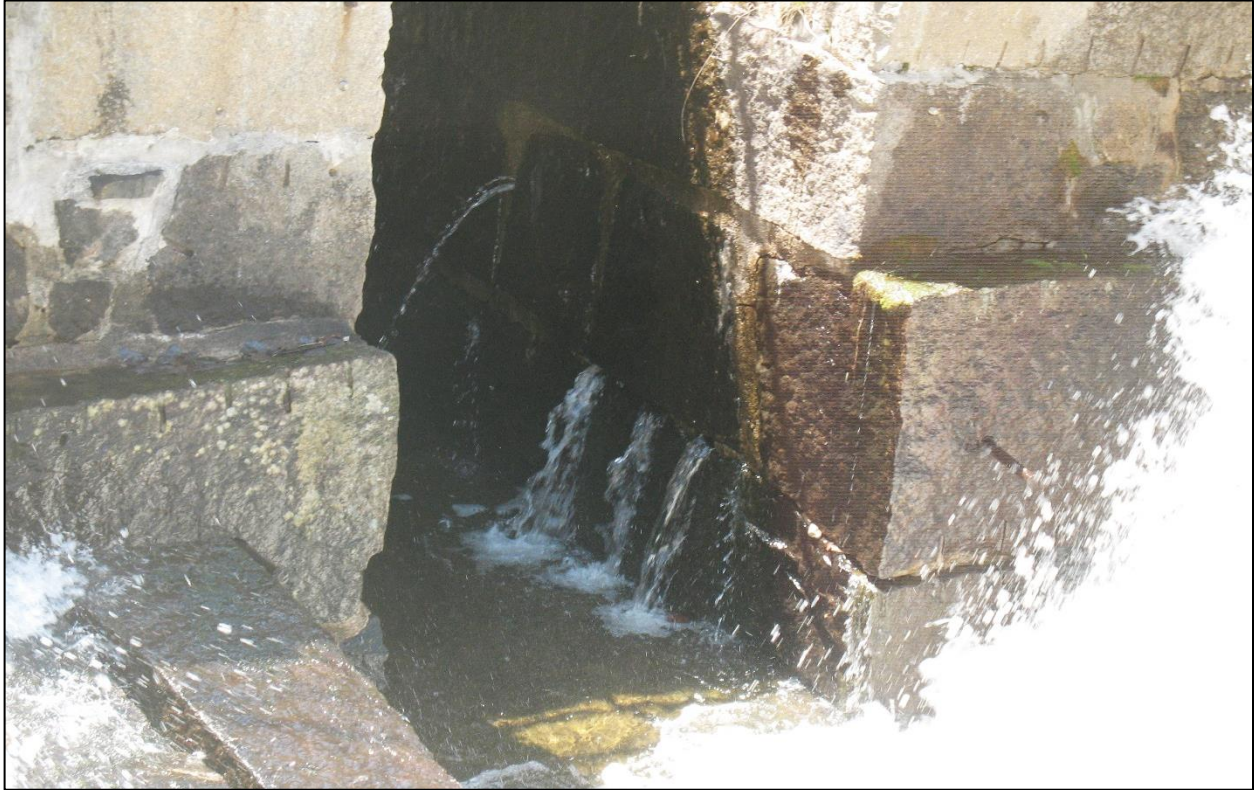
The left and right sluice walls downstream of the gate were leaking near the sluice floor. The estimated combined leakage coming from voids and open joints was about 50-80 gpm (Photos 9, 10). The gate observed at some distance from the downstream appeared relatively watertight (Photo 11).

Photo 9. Downstream View of Central Sluice. Note Leakage in Left Wall.

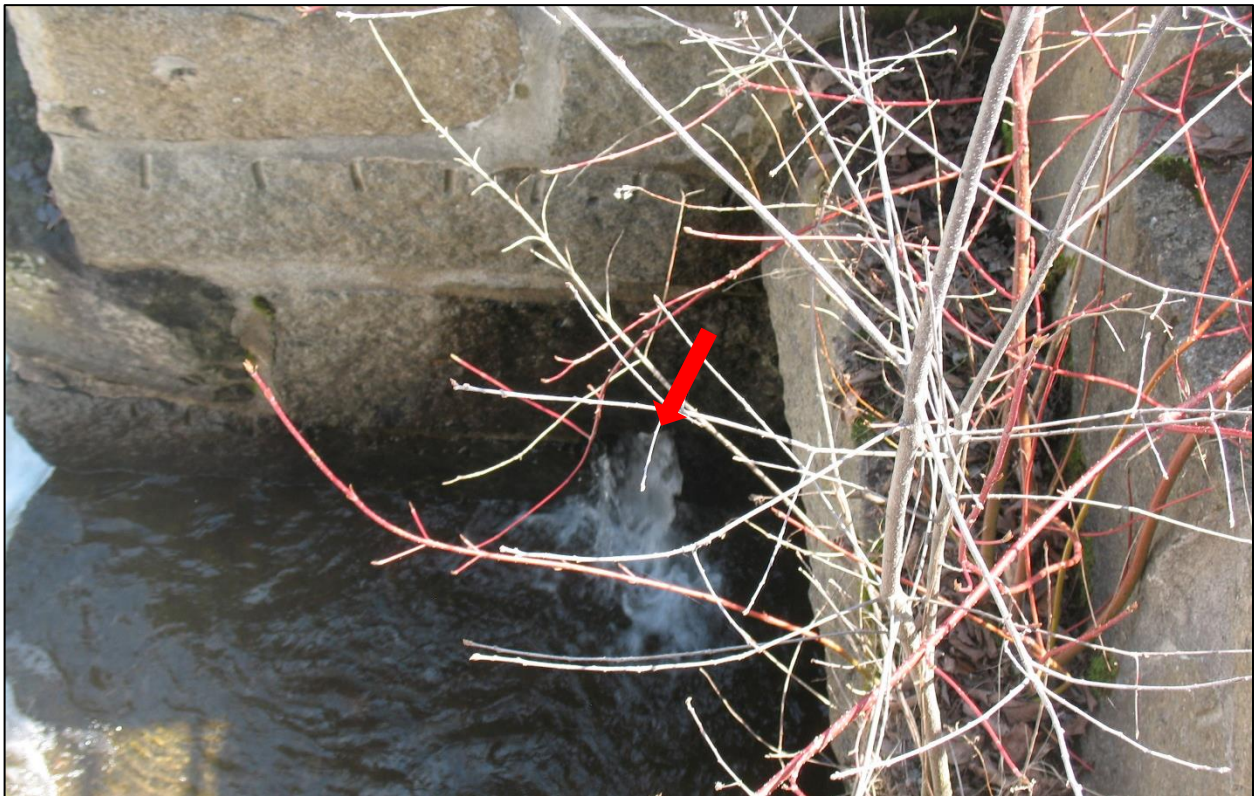
Photo 10. Central Sluice: Significant Right Wall Leakage near Sluice Bottom, Vegetation.

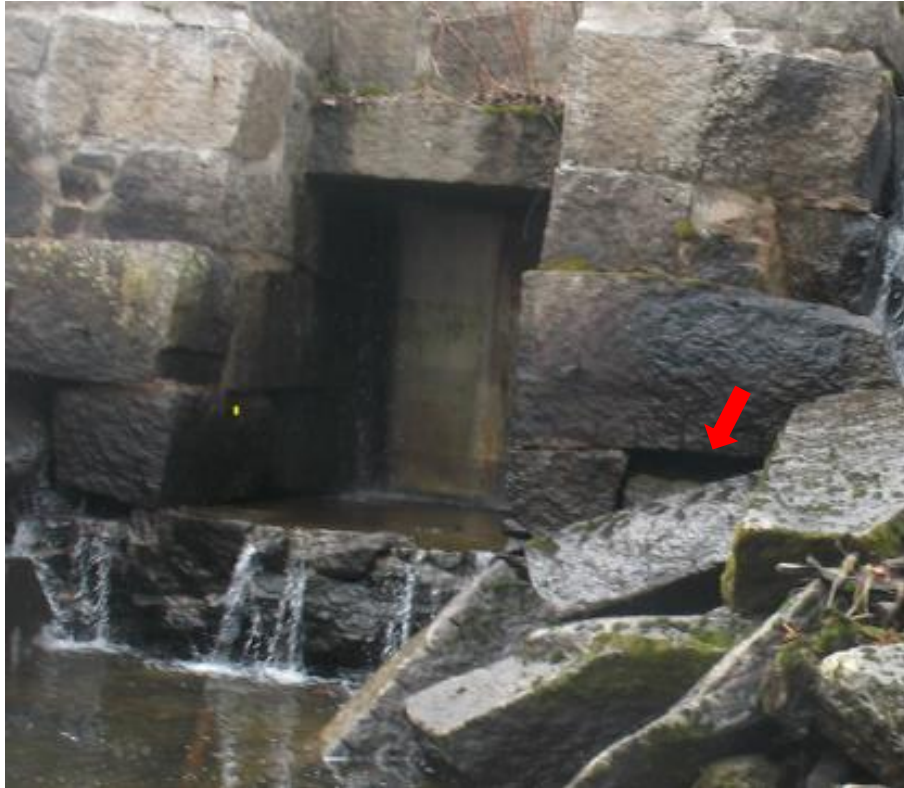
Photo 11. Downstream View of Closed Central Sluice Gate. Note Large Void in Masonry.

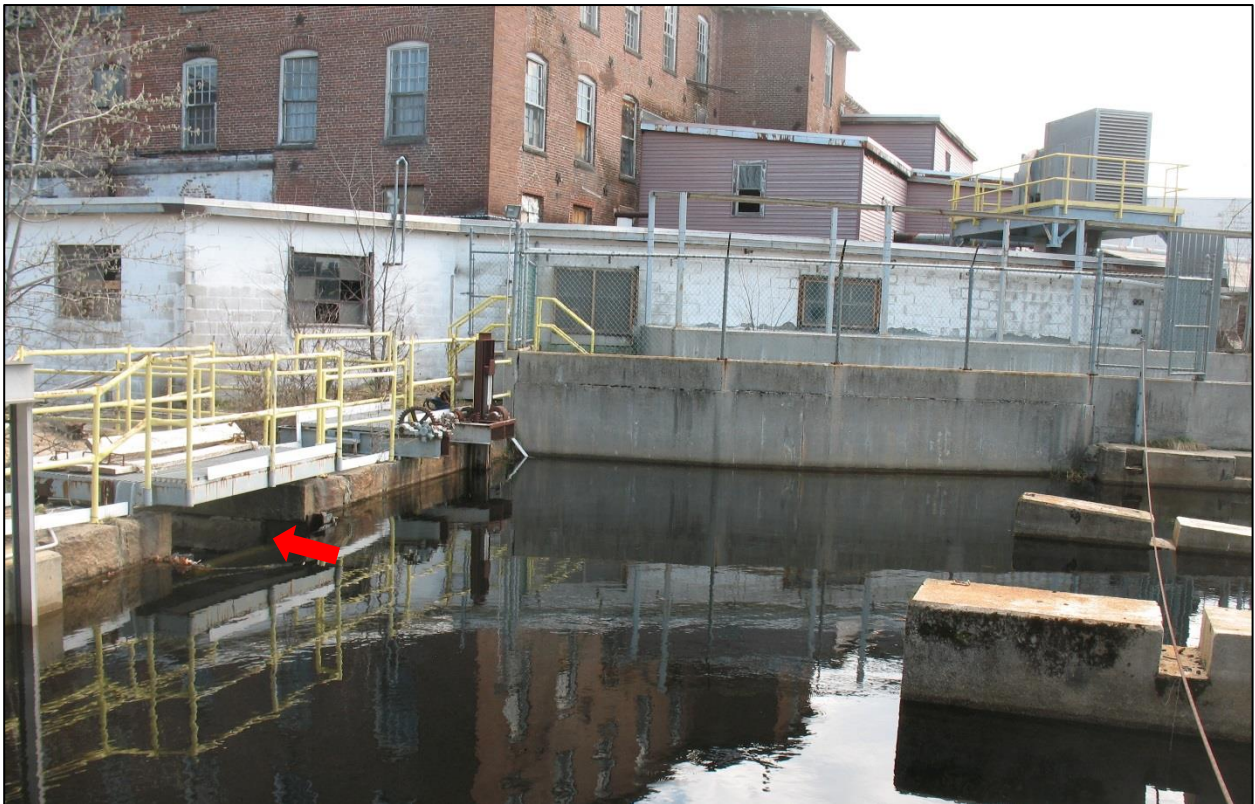
East Sluice. The east sluice is similar in construction to the west sluice (Photo 12). The structure is also a broad-crested weir, about the same width but over 5 feet deeper. The sluice is entirely stoplogged but only four top boards are routinely used for flow control. The steel platform installed for operation of the stoplogs appeared sound but showed signs of rust (Photo 13). The stoplogs observed during the second inspection were extensively leaking with an estimated rate of 2-3 cfs (Photo 14). The sluice walls downstream of the stoplogs contained a number of voids and open masonry joints with mortar missing. The joints were leaking significantly with a total estimated flow of 25-35 gpm (Photos 15, 16). Saplings and brush were observed growing on the top of the left sluice wall with roots established in open masonry joints (Photo 14).

Photo 12. Upstream View of East Sluice.

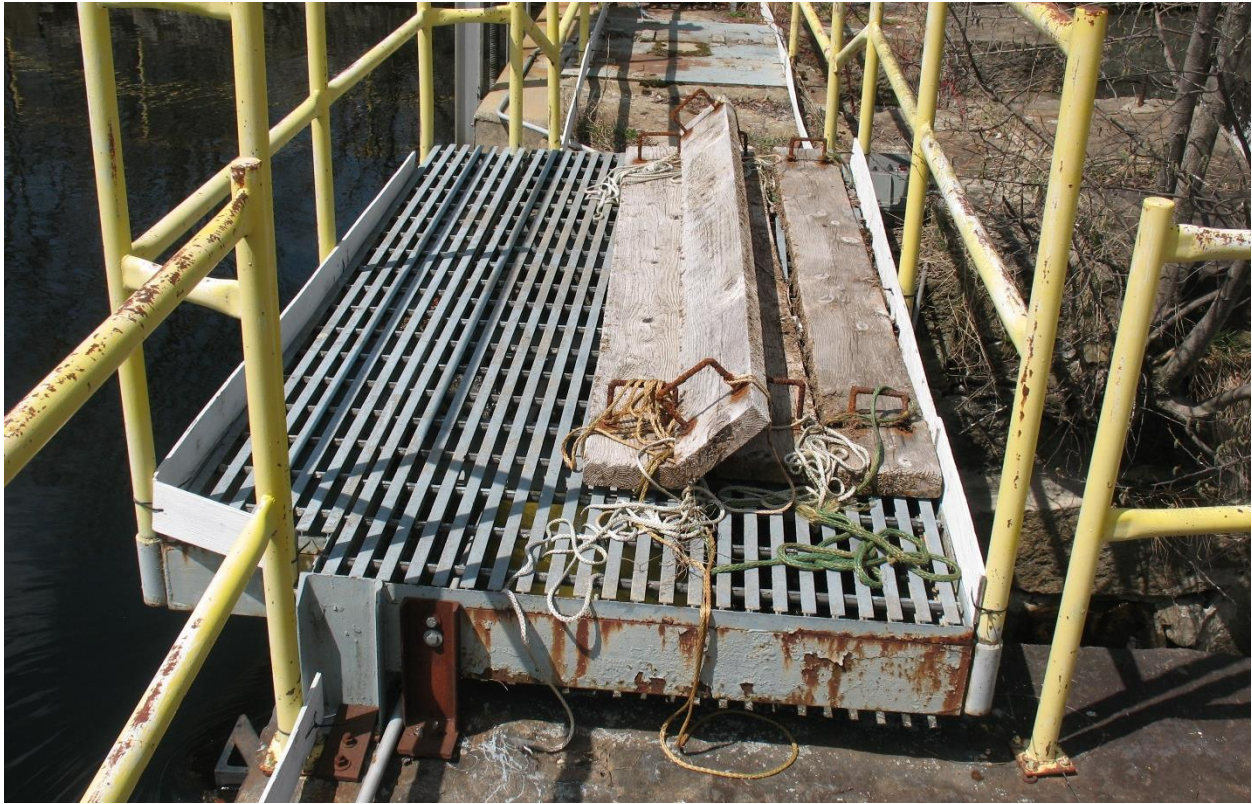
Photo 13. East Sluice Stoplog Operating Platform and Handrail. Note Steel Rust.

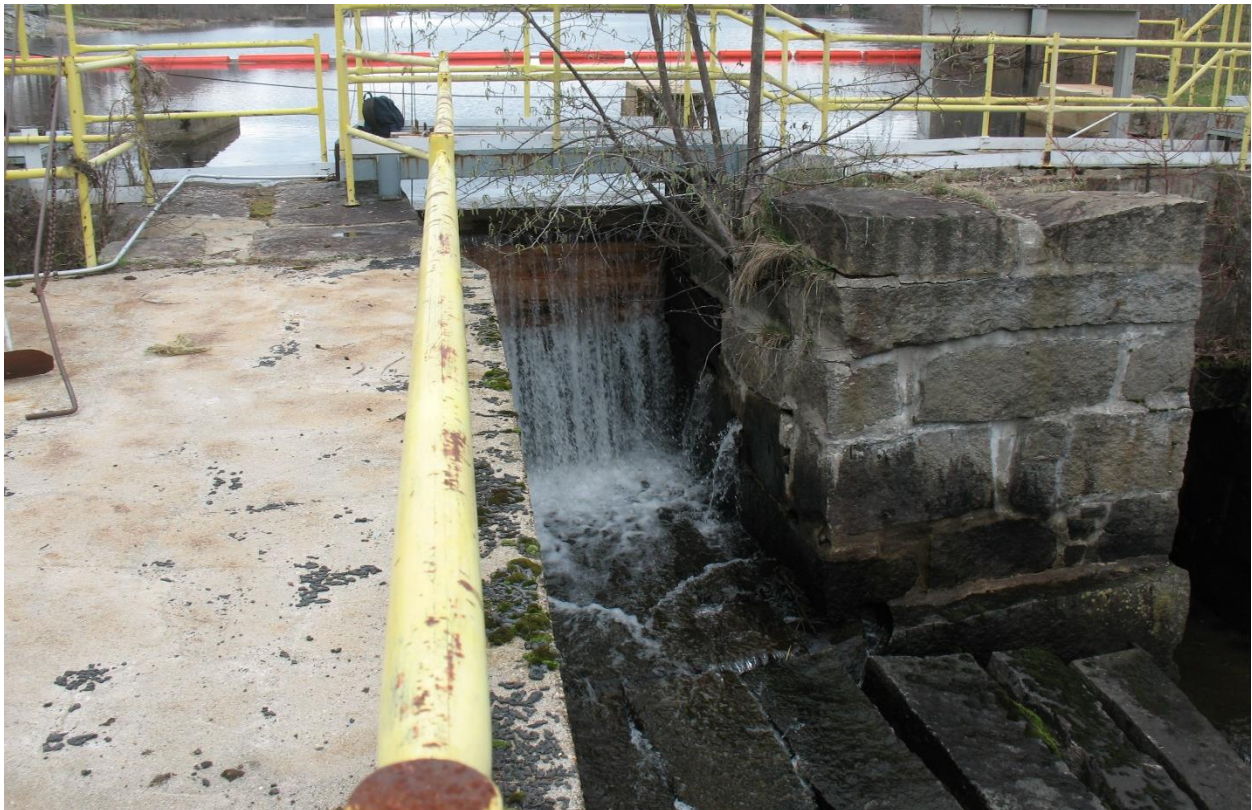
Photo 14. Downstream View of East Sluice. Note Leaking Stoplogs and Trees in Masonry.

2. Trees and brush growing on the dam, west abutment, slopes of the approach channel, and the left stone wall of the discharge channel should be cut and removed to provide unobstructed observation of the dam facilities and vicinity and protect the structures and abutments from damage by root penetration and uprooting.

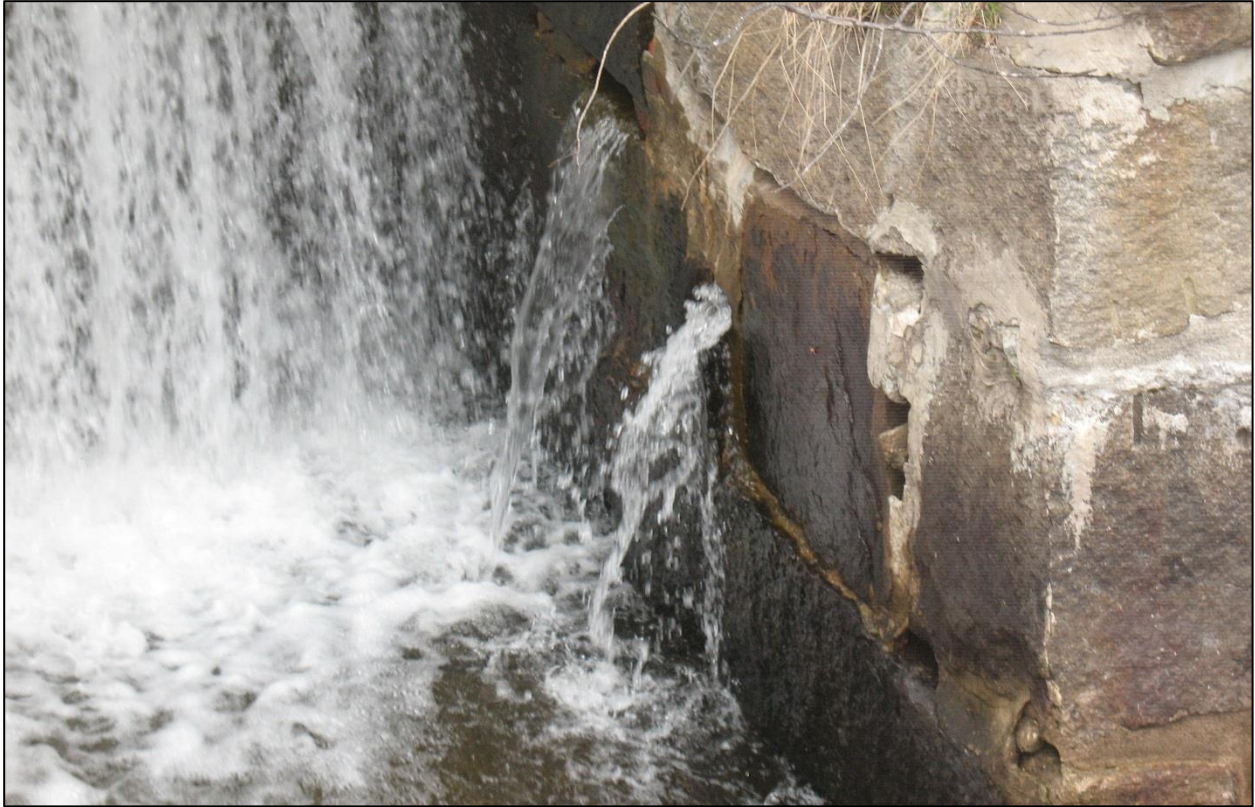
Photo 15. East Sluice Left Wall: Open Voids and Leakage in Masonry.

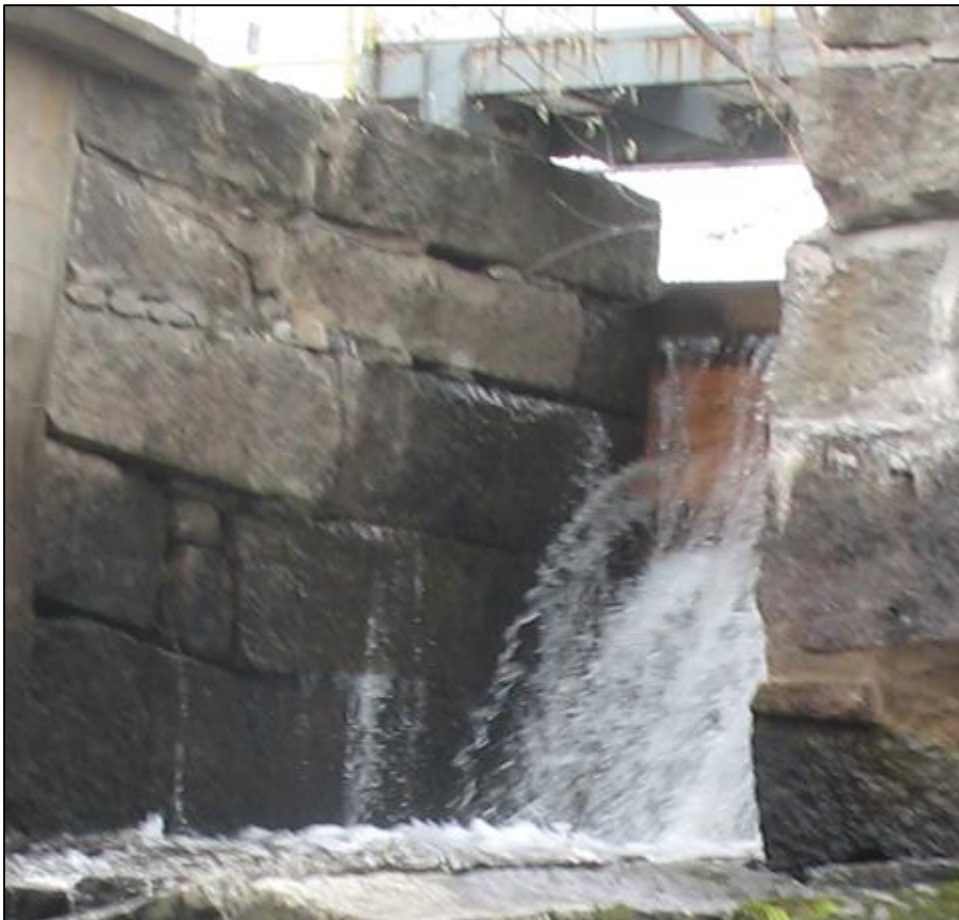
Photo 16. East Sluice Right Wall.  
Note Voids and Leakage in Masonry.

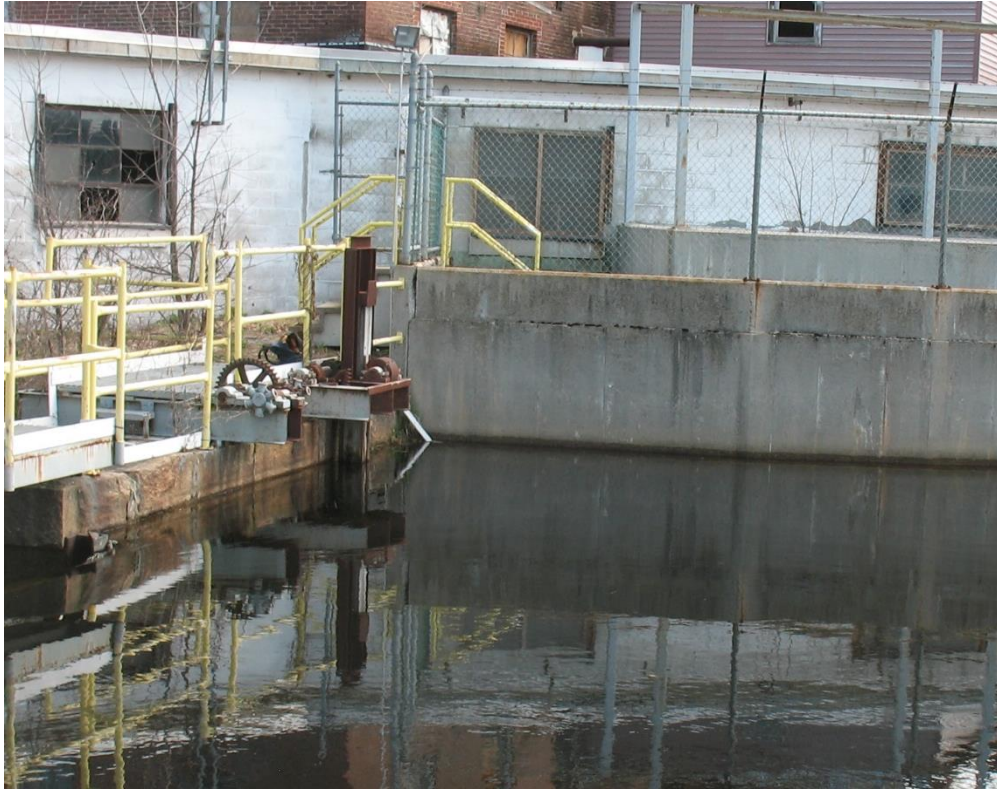
Photo 17. Upstream Face of Concrete Dam Section and Old Water Process Intake Gate Hoist.

7. The old mill water process intake located in the concrete section of the dam is reportedly leaking. The intake should be sealed and the gate equipment removed from the dam. The intake decommissioning method and accompanying documentation (sketches, photos) should be included into the dam records.

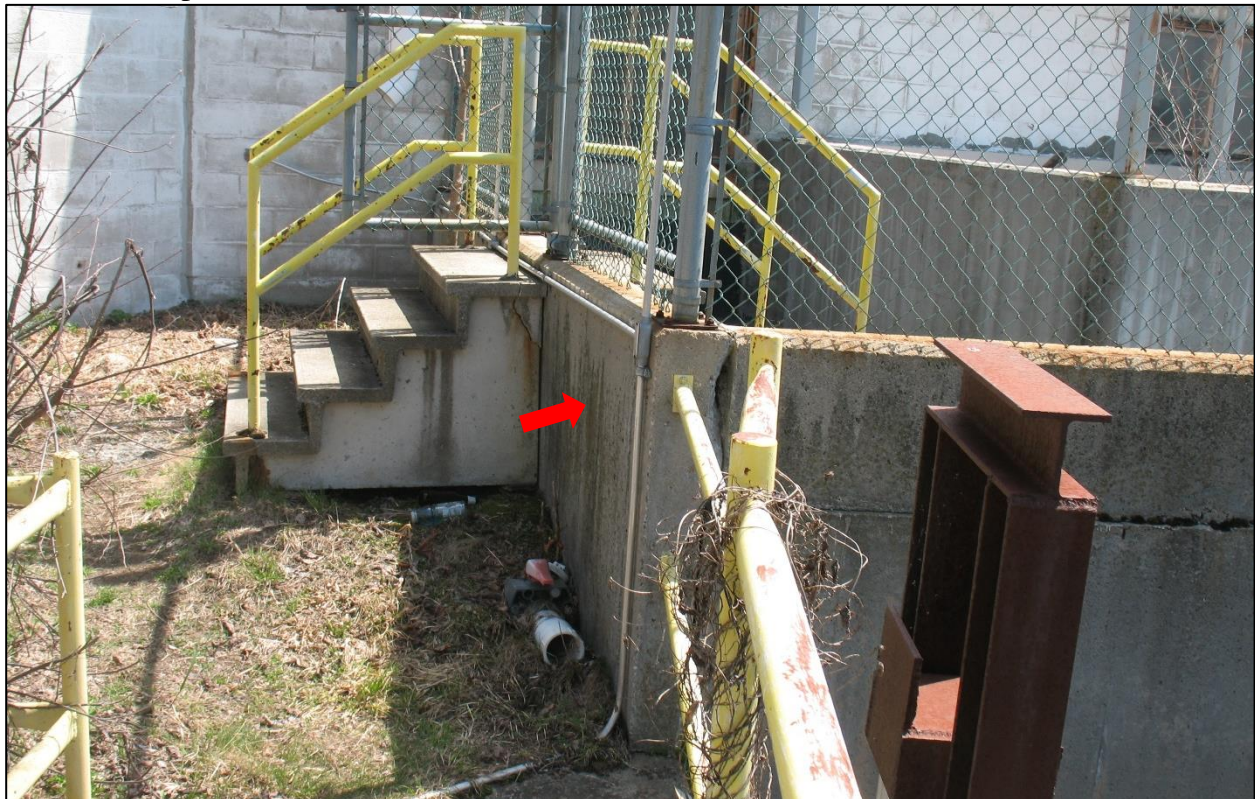
Photo 18. Concrete Dam Section at Mill Building and 3-foot High Concrete Parapet Wall (arrow) on Top of Dam.

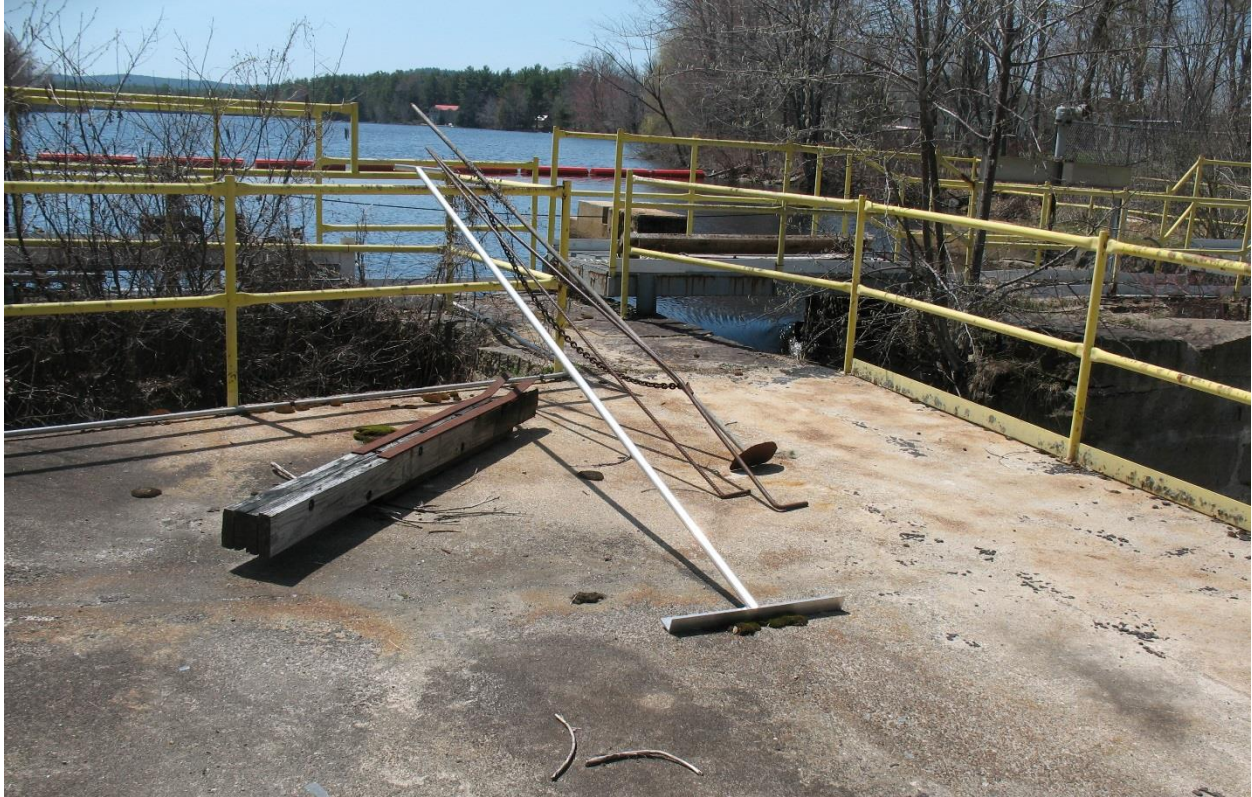
Concrete Section. The 30-foot wide, 36-foot long concrete section of the dam extending between the east sluice and mill building was in adequate condition (Photos 19, 20). The structure contained a gated old process water intake controlled by a rack-and-pinion hoist (Photo 17). The intake gate was reportedly leaking and is currently scheduled for decommissioning. The top of the structure included a 3-foot high, 16-foot long concrete parapet wall extending between the mill building and the flood wall running along the pond shoreline (Photo 18). This flood protection system provides a safe access to the dam from the mill side during significant storms.

Photo 19. Concrete Dam Section Looking Upstream. Note Stored Lifting Rods Used for Stoplog Operation.

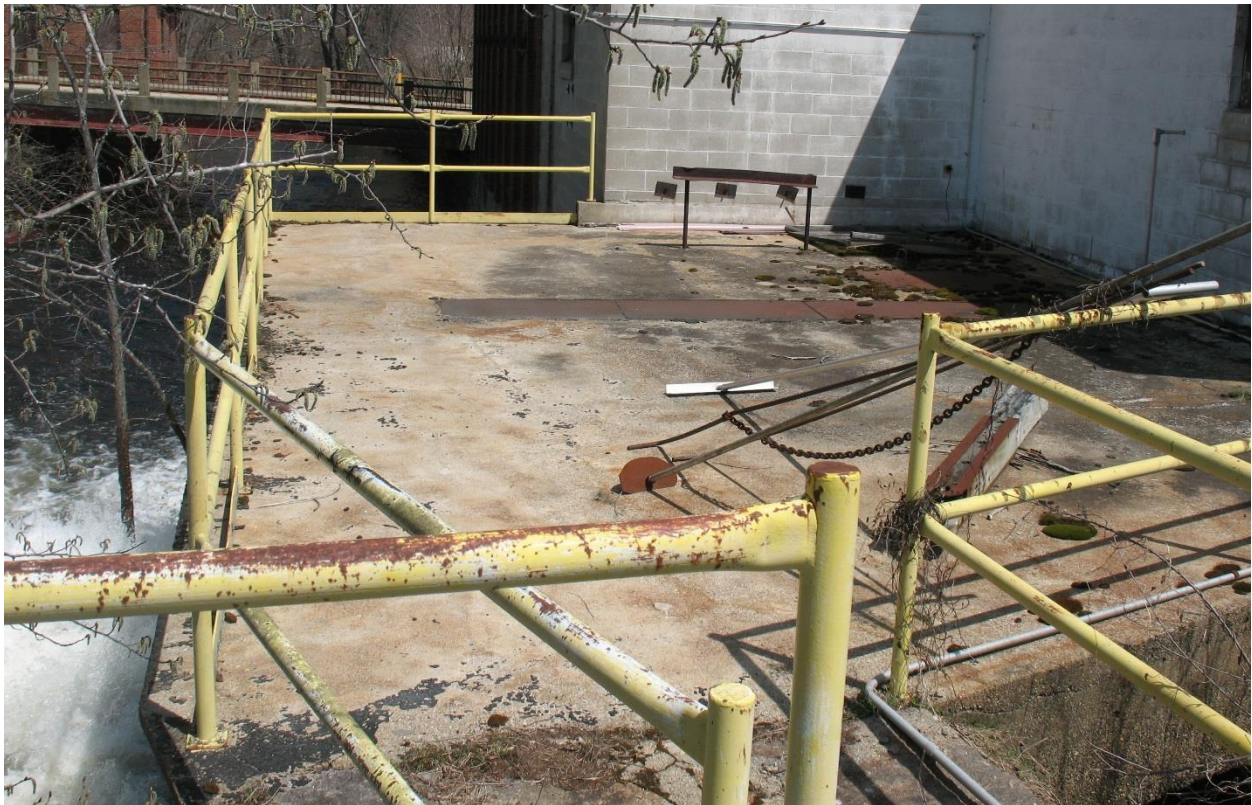
Photo 20. Downstream View of Concrete Dam Section.

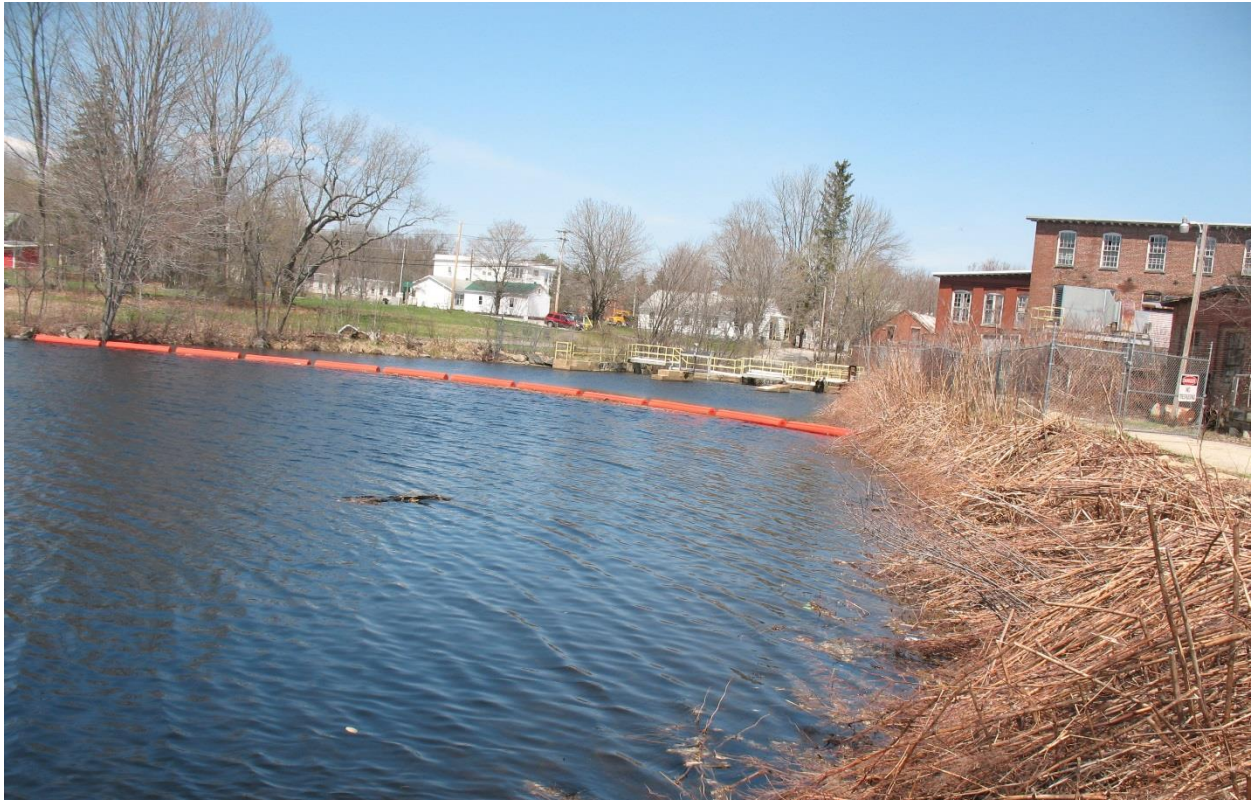
Approach Channel. The approach channel extending between the log boom and the dam includes a concrete flood wall on the right and a short retaining wall on the left installed to protect the low laying abutment (Photo 21). The log boom installed in 2011 appeared in good condition. The right bank of the channel was covered with dense brush obstructing the inspection (Photo 21). A significant number of large trees growing along the left bank near the waterline were apparently undercut by soil erosion (Photo 22). The trees could fall into the pond, block the sluices during high water and reduce the water conveying capacity of the dam. The left retaining wall built of stone masonry and concrete was extending about 25 feet upstream from the dam (Photo 23). The

Photo 21. Log Boom in Approach Channel. Note Left Bank Trees and Right Bank Overgrowth.
