Subject: Inspection of Thompson Lake Dam

The Thompson Lake Dam (Maine ID 00133, NatDam ID ME00016) is located at the outlet of Thompson Lake, on Outlet Stream, a tributary of the Little Androscoggin River, in the Town of Oxford (Town), Cumberland County, Maine (Figure 1). The dam was originally installed around 1800, rebuilt in 1863 and modified in 1974. The 1863 dam reportedly raised the natural lake level by 10 feet. Since 1863 the dam was owned by the Robinson Manufacturing Co. The Robinson woolen textile mill was closed in 2004 and the dam ownership was transferred to the Town of Oxford in 2009. The dam has low hazard classification.

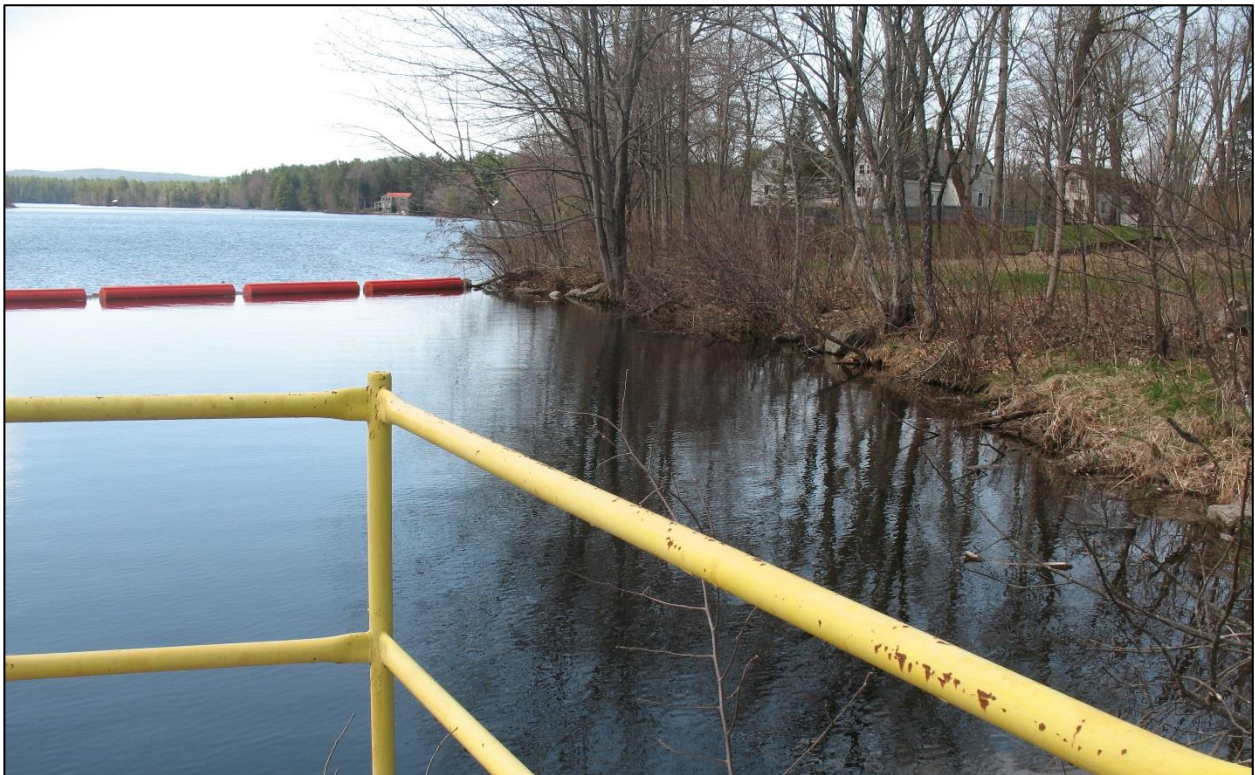
Photo 22. Left Approach Channel Bank Between Log Boom and Dam. Note Large Trees at Waterline.

2. Trees and brush growing on the dam, west abutment, slopes of the approach channel, and the left stone wall of the discharge channel should be cut and removed to provide unobstructed observation of the dam facilities and vicinity and protect the structures and abutments from damage by root penetration and uprooting.

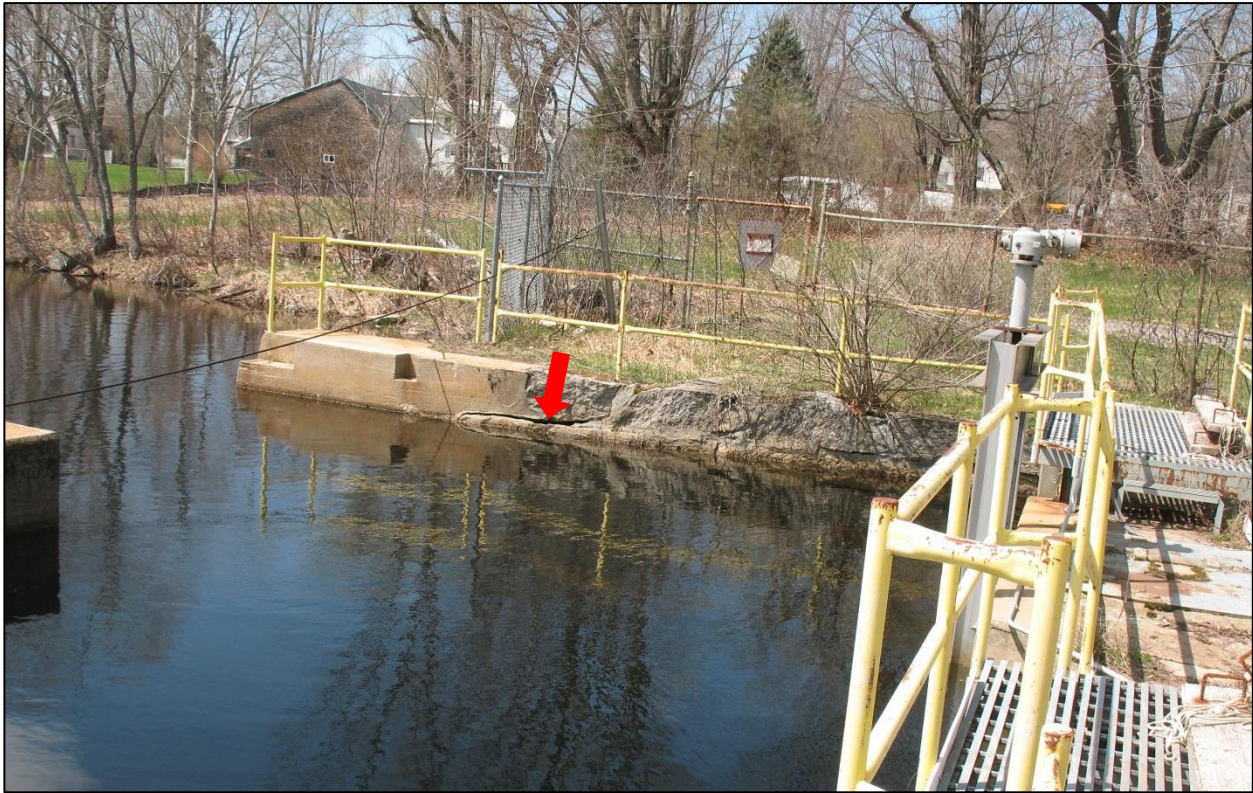
Approach Channel. The approach channel extending between the log boom and the dam includes a concrete flood wall on the right and a short retaining wall on the left installed to protect the low laying abutment (Photo 21). The log boom installed in 2011 appeared in good condition. The right bank of the channel was covered with dense brush obstructing the inspection (Photo 21). A significant number of large trees growing along the left bank near the waterline were apparently undercut by soil erosion (Photo 22). The trees could fall into the pond, block the sluices during high water and reduce the water conveying capacity of the dam. The left retaining wall built of stone masonry and concrete was extending about 25 feet upstream from the dam (Photo 23). The

wall contained a large, near horizontal crack at the waterline. Over a half of the wall concrete cover was eroded away exposing deteriorated masonry.

Photo 23. Left Approach Channel Retaining Wall. Note Wall Erosion and Large Crack at Waterline.

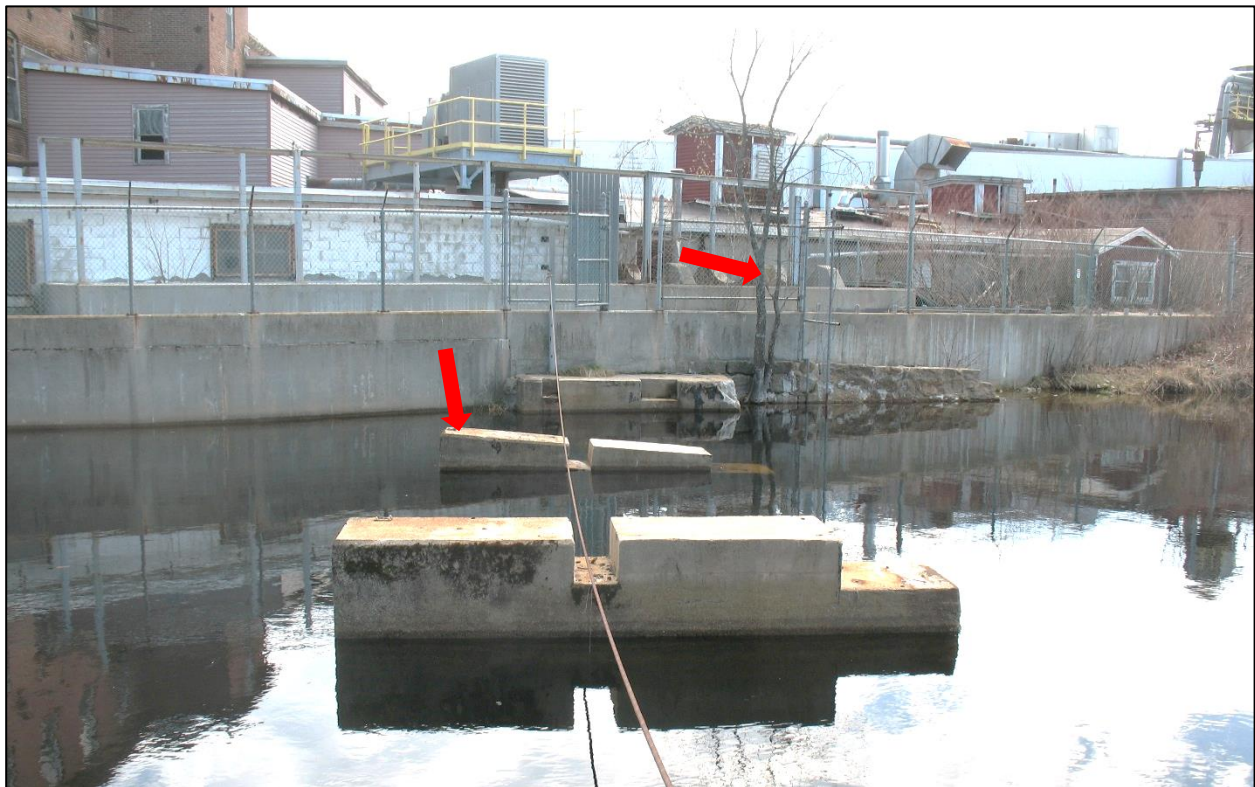
Three concrete piers in the approach channel, each 2 feet wide, 12 feet long (per the 1998 MEMA inspection report), were situated close to the dam. The piers in the past supported a trashrack and a catwalk used for debris removal. The central pier was observed sagging and tilting toward the lake (Photo 24). This pier movement was not noticed during the 1998 inspection of the dam. The piers can obstruct the flow, catch debris and reduce hydraulic efficiency of the channel.

upstream. This phenomenon, not observed during the 1998 MEMA inspection, could be the result of the pier base erosion by the channel currents or dam foundation seepage. Trees and brush growing on both banks of the waterway may contribute to the amount of debris entering the channel. The retaining wall installed along the west bank of the approach channel has experienced cracking, concrete cover failure and significant deterioration of the stone masonry. This retaining wall protects the low-lying abutment against erosion and controls seepage around the dam.

Photo 24. Right Approach Channel Retaining Wall and Old Piers Supporting Original Trashracks and Catwalk. Note Sagging Central Pier and Tree at Waterline.

4. The concrete piers located immediately upstream of the dam and obstructing the flow in the approach channel should be removed. Prior to the removal, the central tilted and unstable pier should be observed by divers for base undermining which could be caused by the channel currents and/or dam foundation leakage. The diver's findings should be documented and evaluated.

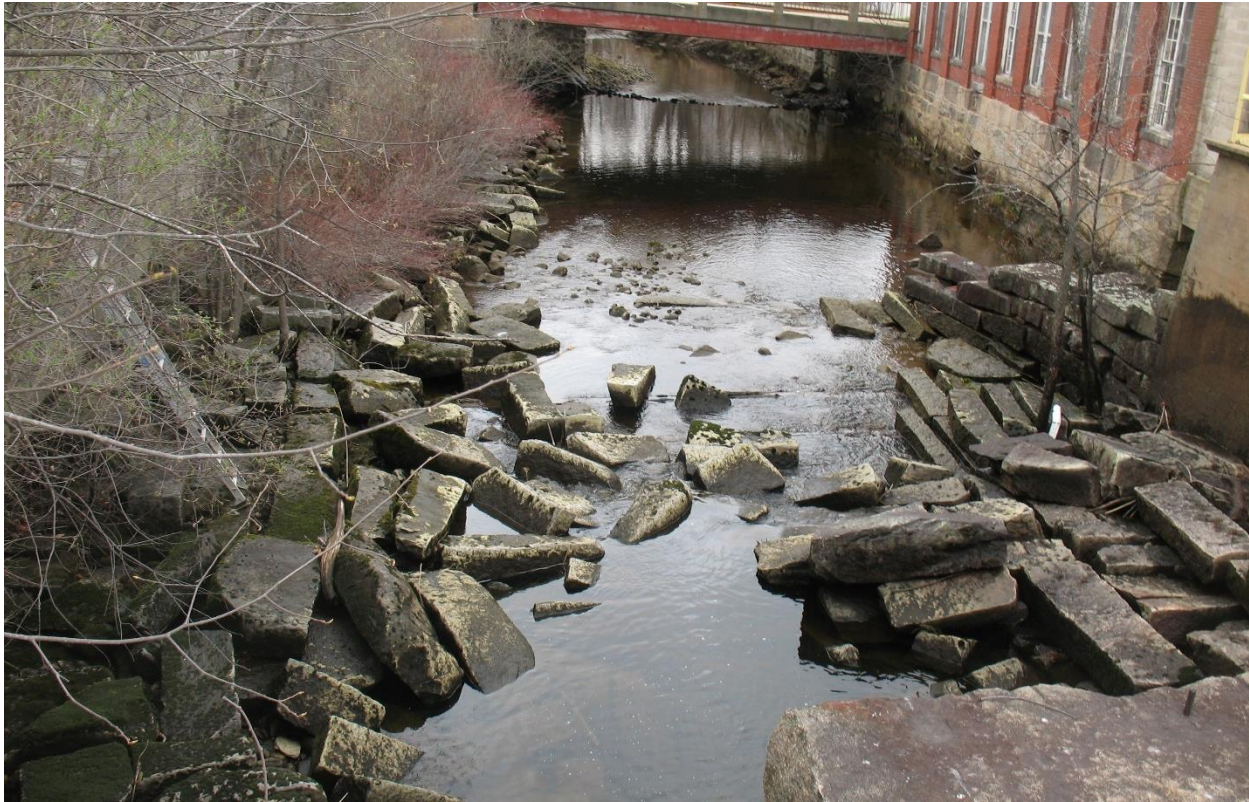
Discharge Channel. The discharge channel at the dam includes a mill building on the right, a stone apron on the streambed and a stone retaining wall on the left (Photo 25). The mill building of concrete substructure and brick superstructure appeared in adequate condition.

Photo 25. Discharge Channel. Left Channel Side Obscured by Dense Vegetation.

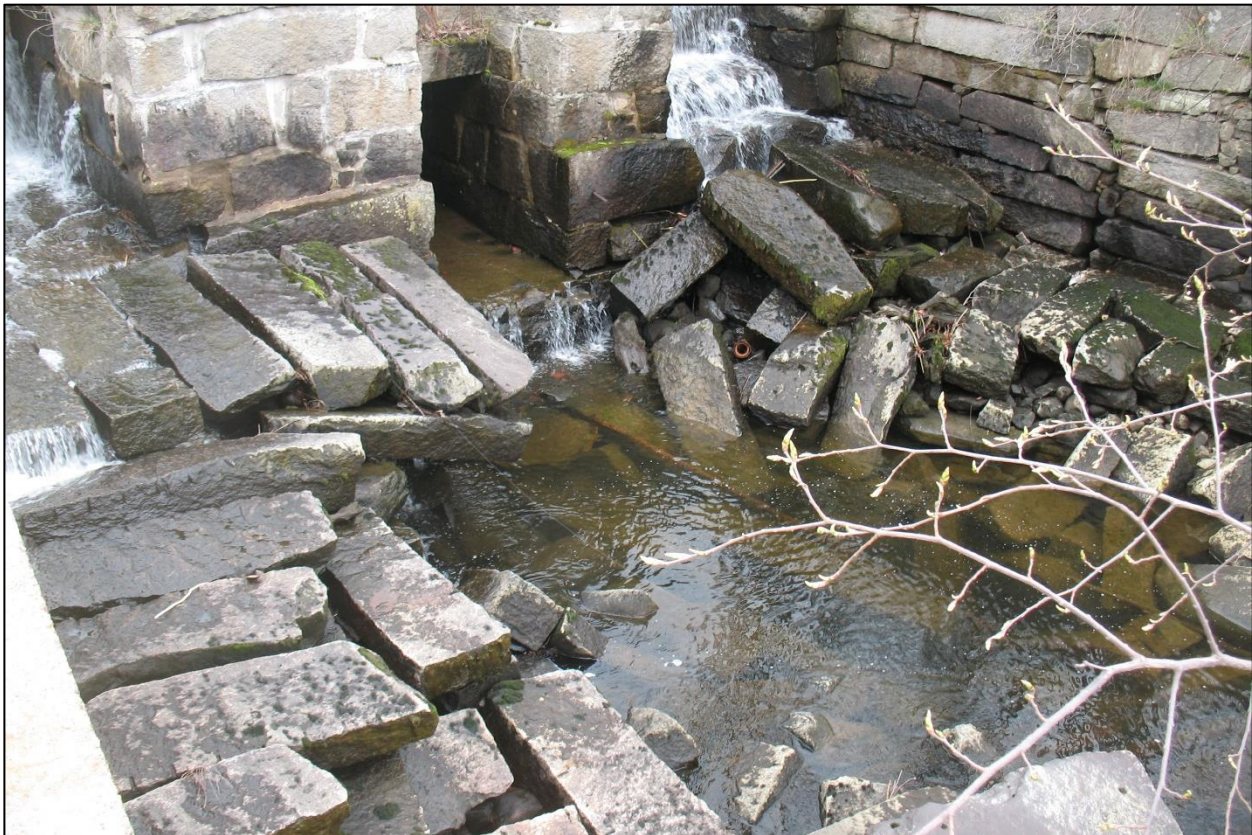
10. The inspection observed almost complete disintegration of the apron area aligned along the central gate sluice with stone blocks moved and washed out. The apron areas downstream of the east and west sluices were also significantly damaged with stone slabs distorted, displaced and partially missing. Severe deterioration of the apron could be caused by operation of the dam, design and construction deficiencies, and the lack of maintenance. It is also possible that the past dam overtopping events have contributed to deterioration of the apron.

11. The lack of the streambed protection has resulted in formation of a deep scour hole (plunge pool) at the toe of the dam. The hole was positioned at the toe of the central sluice and extended about 30 feet downstream. A similar condition of the apron was observed 20

Photo 26. Disintegrated Stone Apron. Note Scour Hole at Dam Toe and in Channel Floor.

11. The plunge pool scoured in the stone apron of the discharge channel at the toe of the dam should be inspected by divers. The depth and extent of the pool and the location of the dam base, if exposed, should be determined. During the underwater inspection, the scour hole should be observed for signs of erosion, undermining, instability and seepage. The diving inspection findings should be reported, documented, evaluated and remedial measures developed, as necessary.

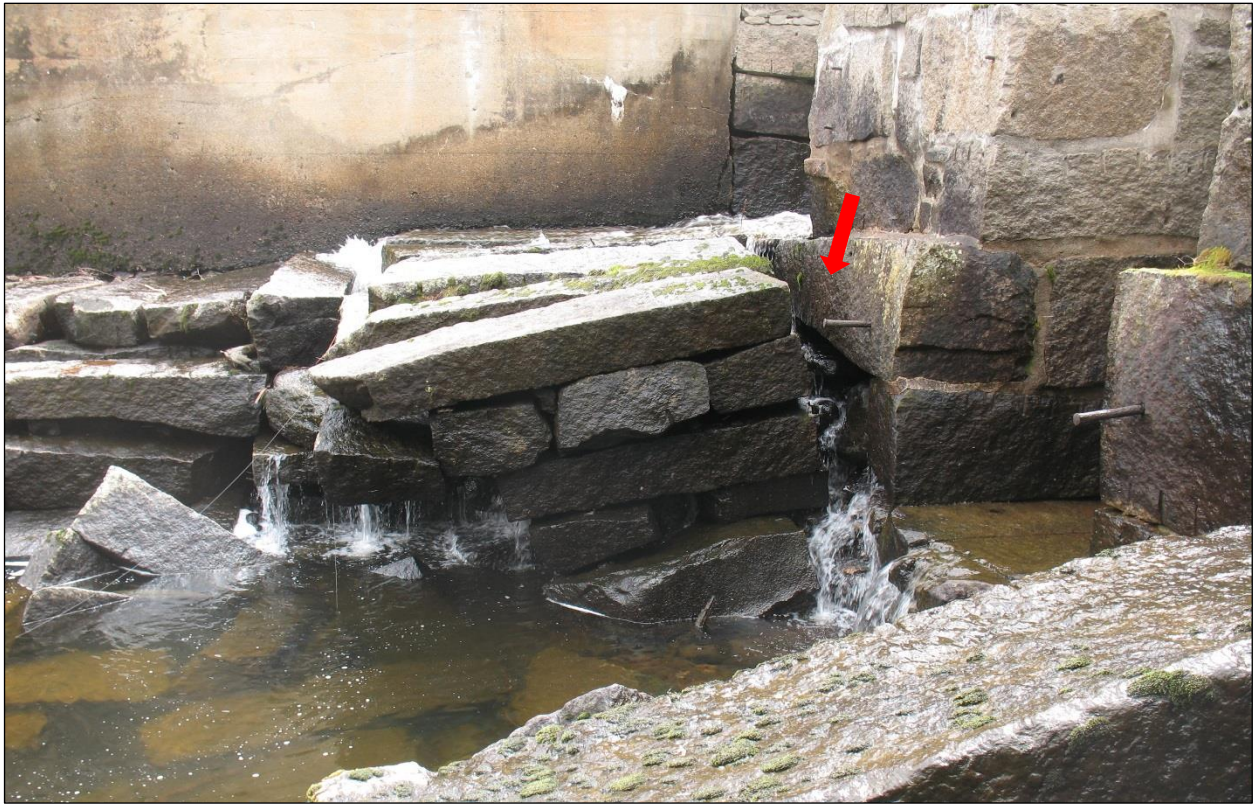
Photo 27. Movement and Separation of Stone Apron Block from Dam.

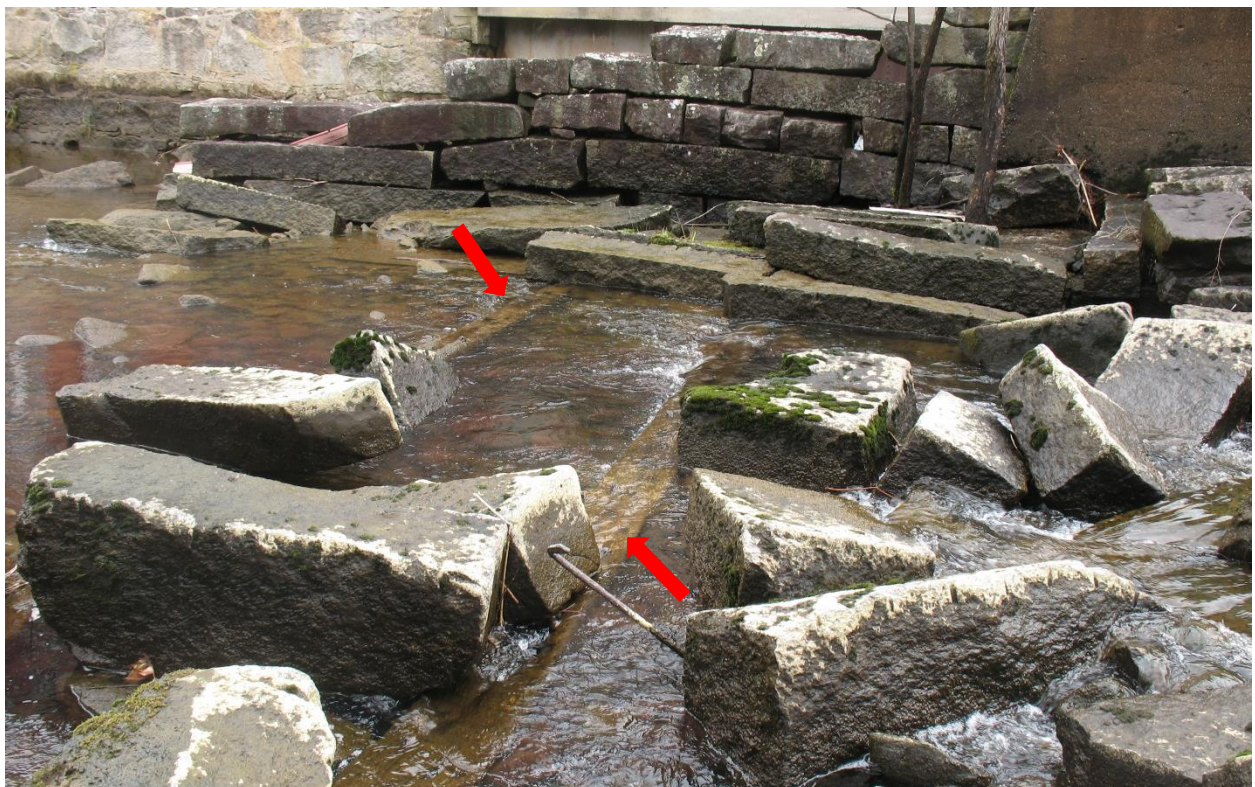
9. The downstream discharge channel at the dam is protected with a cut stone apron. The dam is judged to be built on soil foundation and the apron performs a critical role in protecting the toe of the dam against erosion and undermining. The apron appeared to be heavily built with up to 4 to 6 layers of stacked granite slabs placed over timber cribbing. The cribbing likely used as the base support and leveling measure could facilitate movement of the stone blanket.

Photo 28. Exposed Base Timber Cribbing Used for Apron Construction.

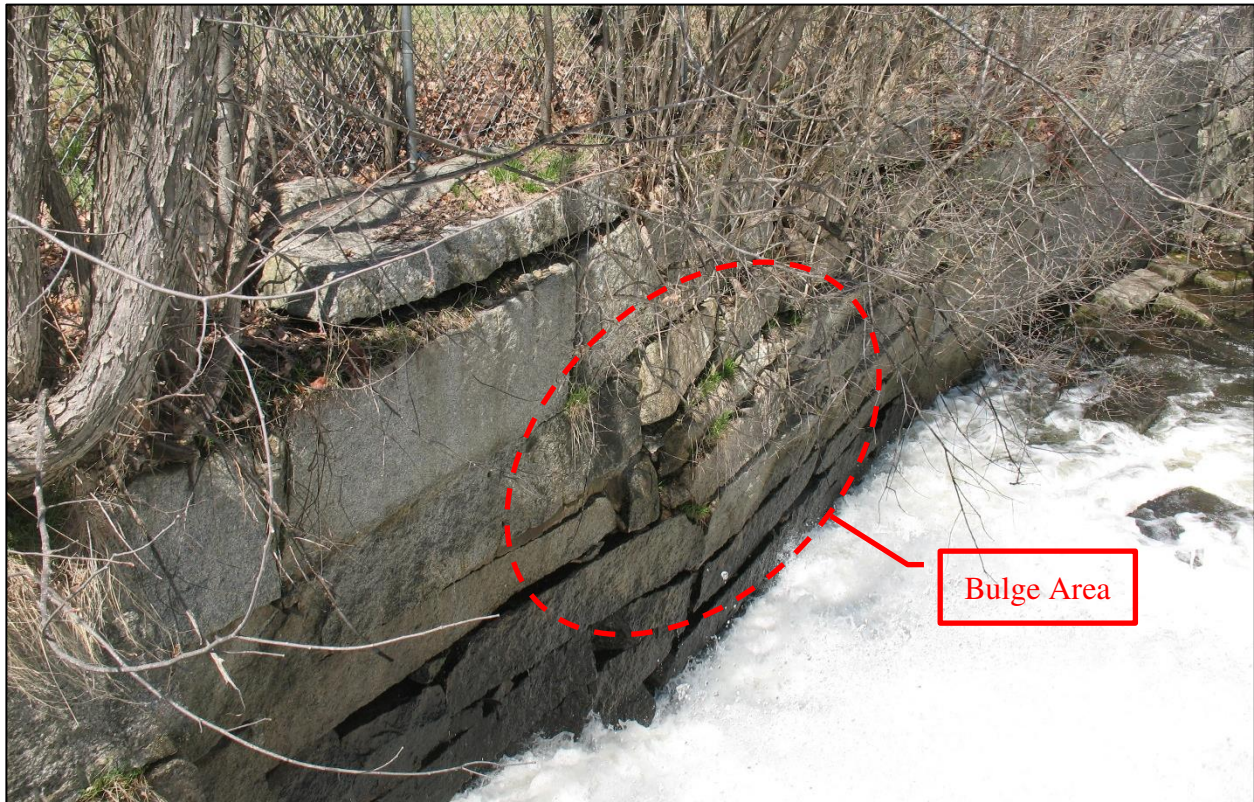
The left, 10 to 12-foot high dry-laid stone retaining wall extending between the dam and access mill bridge was in poor condition (Photos 29, 30). The wall contained a significant number of large voids and widely open joints with chinking stone missing, and many cap slabs displaced or absent. The wall was heavily overgrown with tree and bush. Tree roots were penetrating into the structure dislodging and moving large stone slabs. The structure showed signs of instability: the wall area located 10-15 feet from the dam was out of plumb and bulged toward the discharge channel (Photo 29). Failure of the wall may cause stability concerns of the west dam abutment and channel bank.

12. The left stone retaining wall of the discharge channel contained large voids and wide-open joints. The cap slabs were missing and displaced at several locations. The abundance of large voids in the masonry has resulted in dense wall overgrowth consisting of large trees, saplings, and brush with roots penetrating into the masonry and dislodging stone. The wall was out of plumb and bulging toward the stream at the location about 10-15 feet downstream from the dam. This wall displacement is not recent occurrence and was observed during the 1998 MEMA inspection. The bulge could be indication of potential instability of the wall. Failure of the wall may weaken the west abutment, affect dam and channel slope stability and initiate seepage around the dam.

Photo 29. View of Left Discharge Channel Retaining Wall from Dam. Note Bulging, Displaced and Missing Stone, Voids, Large Trees and Brush.

13. The left stone retaining wall of the discharge channel exhibited bulging area located about 10-15 feet downstream of the dam. The wall bulging usually indicates a potential instability and safety concerns. However, this bulging is not a recent occurrence and was observed during the 1998 MEMA inspection. To assess the need and urgency of the wall remediation, it is recommended to establish survey monitoring of this area. The survey should be performed annually for 3 to 5 years and the collected data evaluated for movement and settlement. The survey set-up should be documented. Based on the survey findings, the need and timing for the wall repair should be assessed.
14. Warning signs on both dam abutments and along the approach and discharge channels should be installed to improve public safety, mitigate vandalism, and reduce the Town's potential liability in the event of accidents.

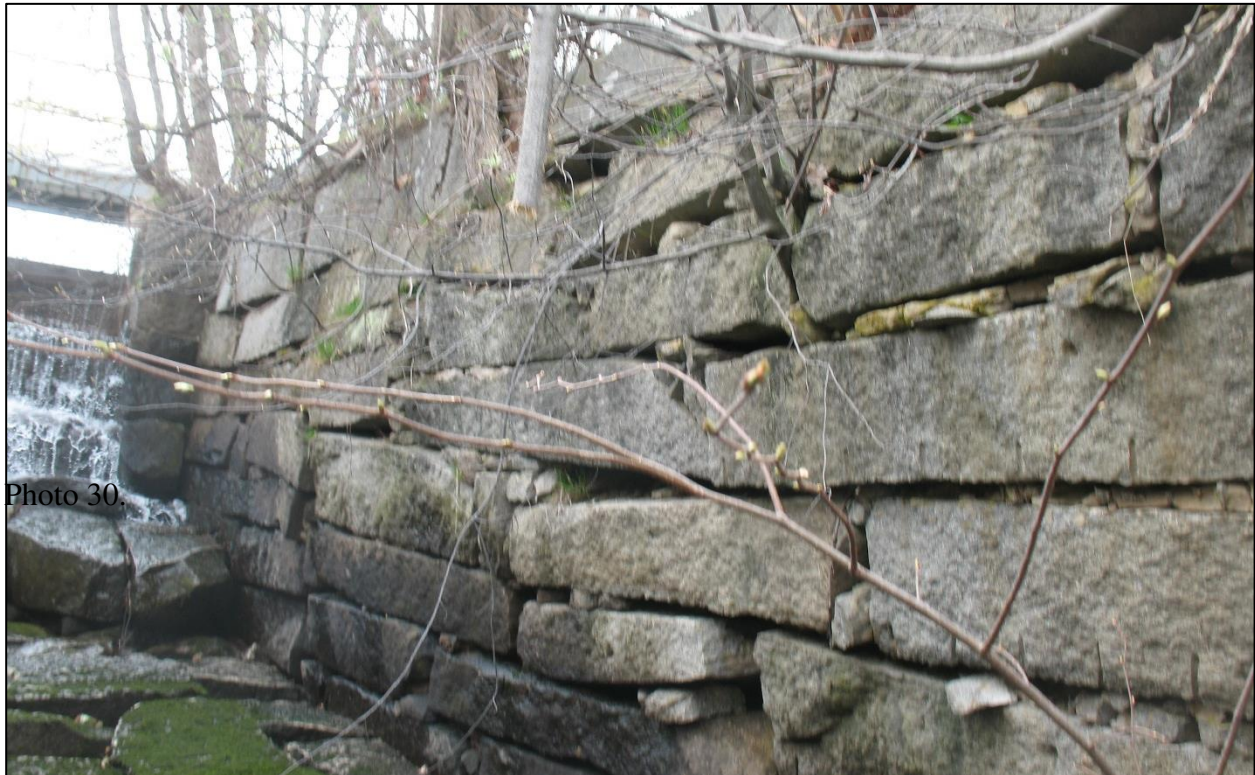
Photo 30. View of Left Discharge Channel Retaining Wall from Channel Floor.
