# THOMPSON LAKE Watershed Survey Report

**MAY 2023**

Thompson Lake Environmental Association

Cumberland County Soil & Water Conservation District

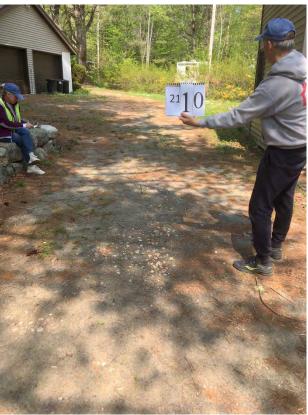
Site 21-10: Low impact driveway site that has identified sheet erosion.

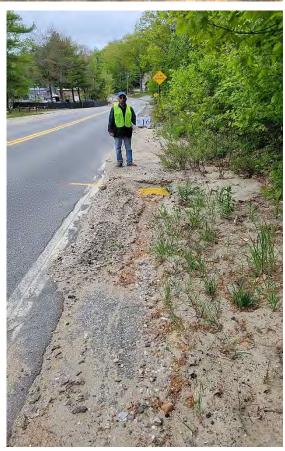
Site 12-16: High impact state road site that has identified gully surface erosion, a clogged and unstable culvert, ditch erosion, road shoulder erosion, and buildup of winter sand, and evidence of a considerable amount of sediment and gravel washing into a catch basin.

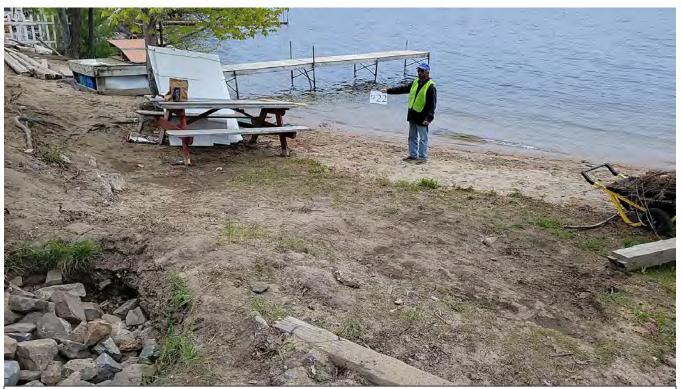
Site 12-22: High impact beach access site. This site has identified surface erosion in the form of sheet, rill, and gully erosion, as well as bare soil, shoreline erosion, and a lack of shoreline vegetation as primary problems.

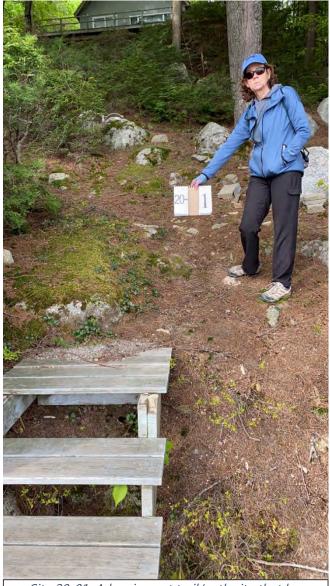
Site 20-01: A low impact trail/path site that has identified sheet surface erosion.

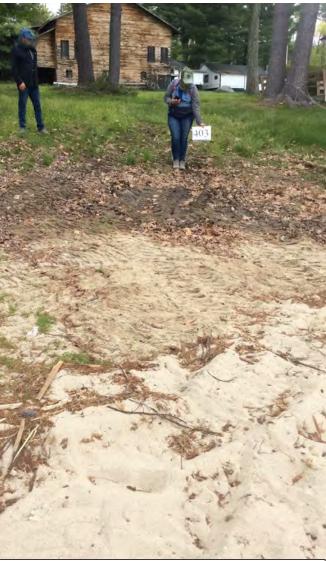
Site 4-03: A high impact commercial site. This site has identified gully surface erosion, shoreline erosion, and inadequate shoreline vegetation as primary problems.

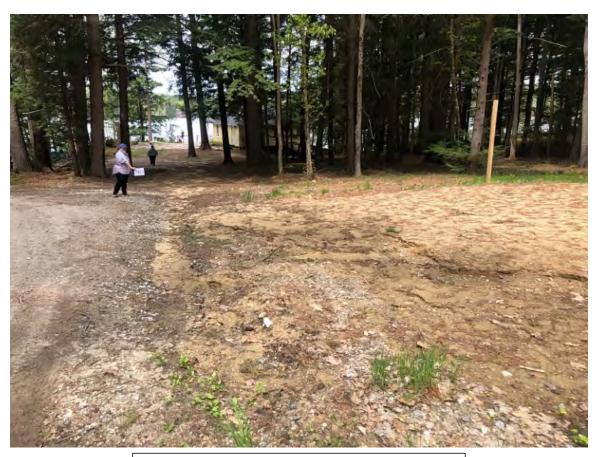
Site 7-03: A medium impact 'other' site that has identified gully sheet erosion at a volleyball court in Sector 7

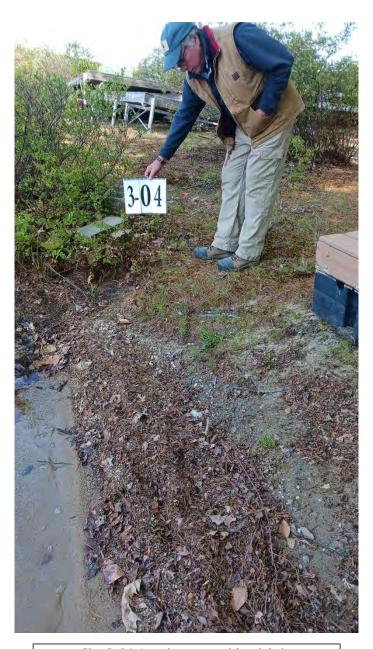
Site 3-04: Low impact residential site.

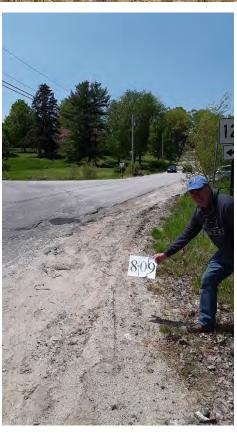
Site 8-09: Medium impact town road site.

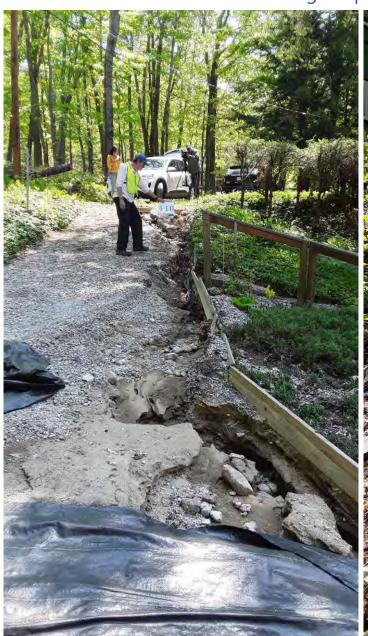
Site 1-10: High impact residential site. Large area experiencing gully erosion flowing directly into the lake without a buffer.

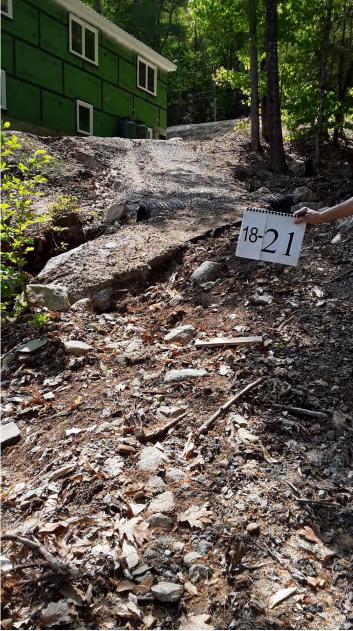
Site 18-21: High impact residential site. Few erosion and sediment controls for active construction on site.

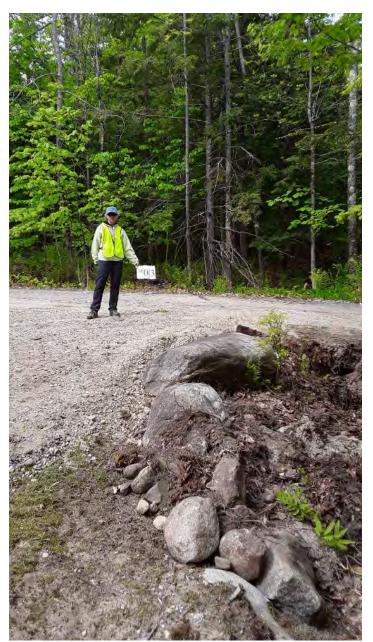
Site 26-03: High impact private road site.

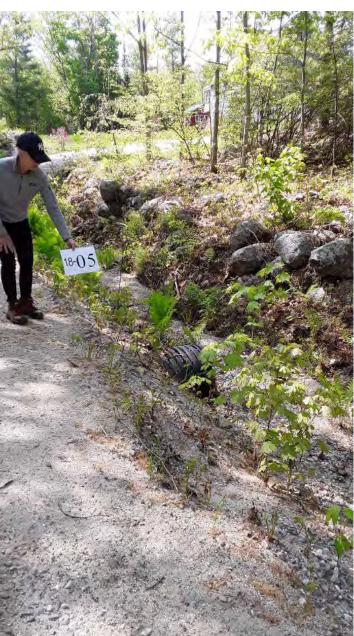
Site 18-05: High impact town road site.
