THOMPSON LAKE Watershed Survey Report

MAY 2023

PREPARED FOR:
Thompson Lake Environmental Association

PREPARED BY:
Cumberland County Soil & Water Conservation
District

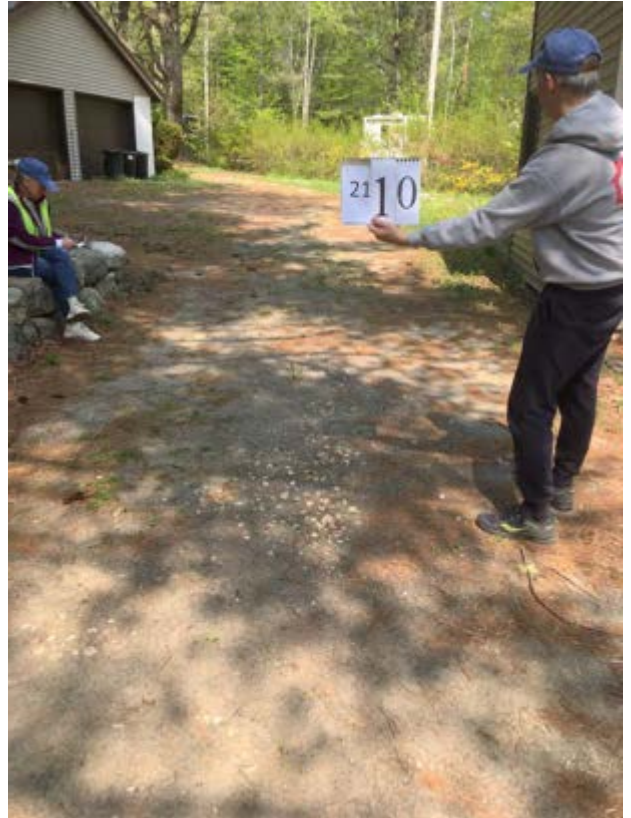
Site 21-10: Low impact driveway site that has identified sheet erosion.

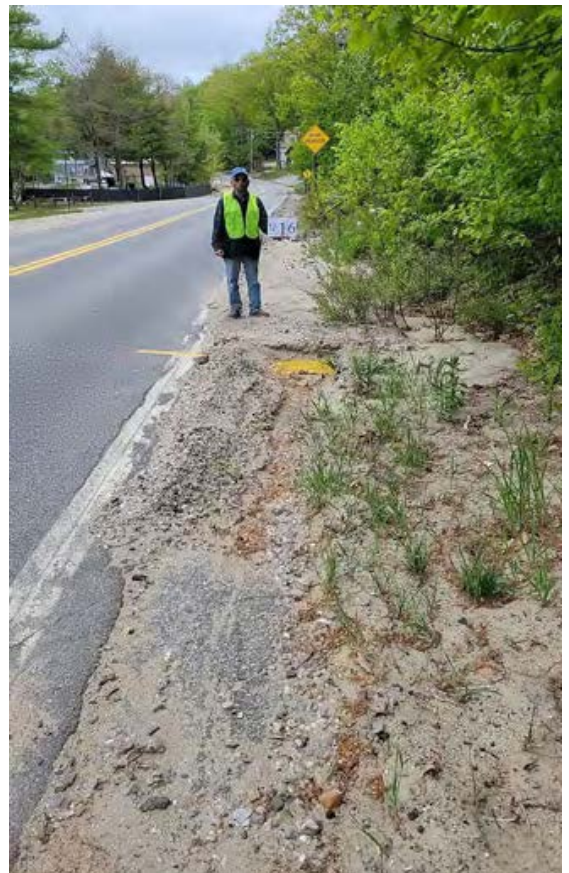
Site 12-16: High impact state road site that has identified gully surface erosion, a clogged and unstable culvert, ditch erosion, road shoulder erosion, and buildup of winter sand, and evidence of a considerable amount of sediment and gravel washing into a catch basin.

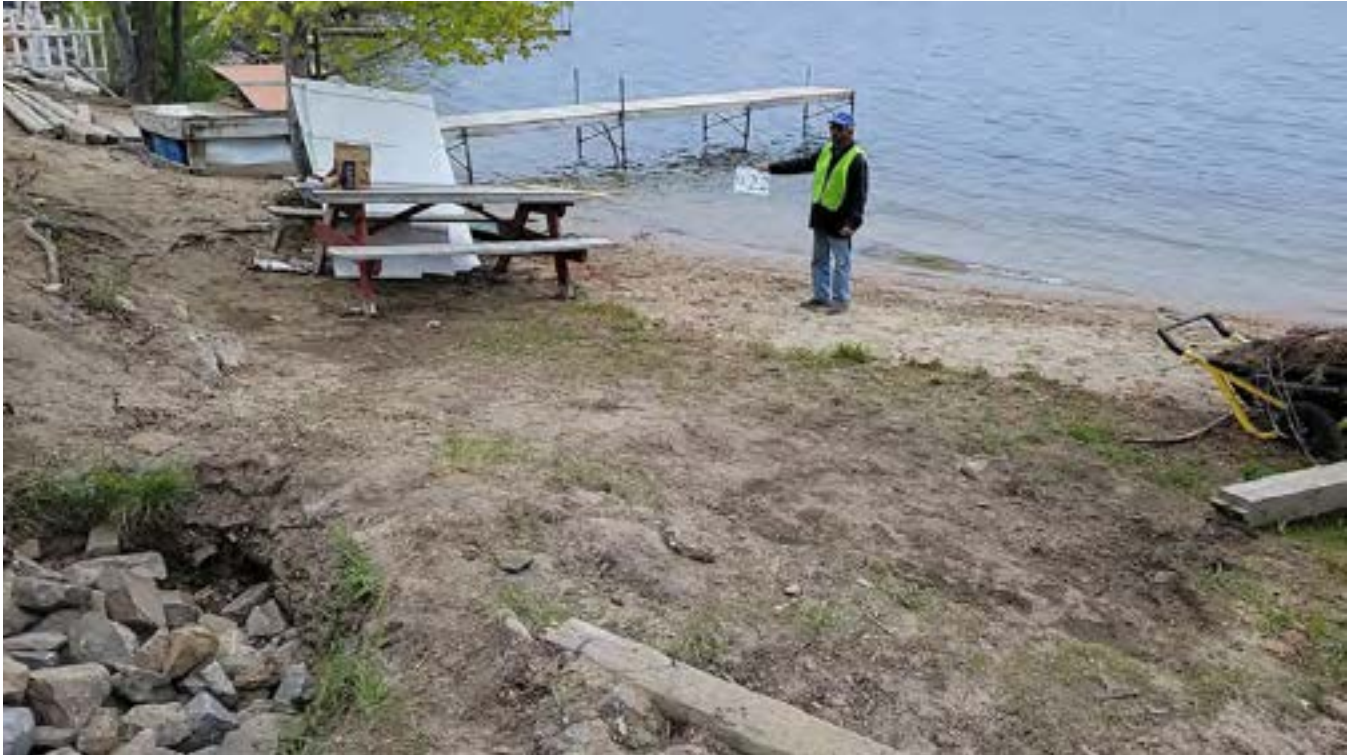
Site 12-22: High impact beach access site. This site has identified surface erosion in the form of sheet, rill, and gully erosion, as well as bare soil, shoreline erosion, and a lack of shoreline vegetation as primary problems.

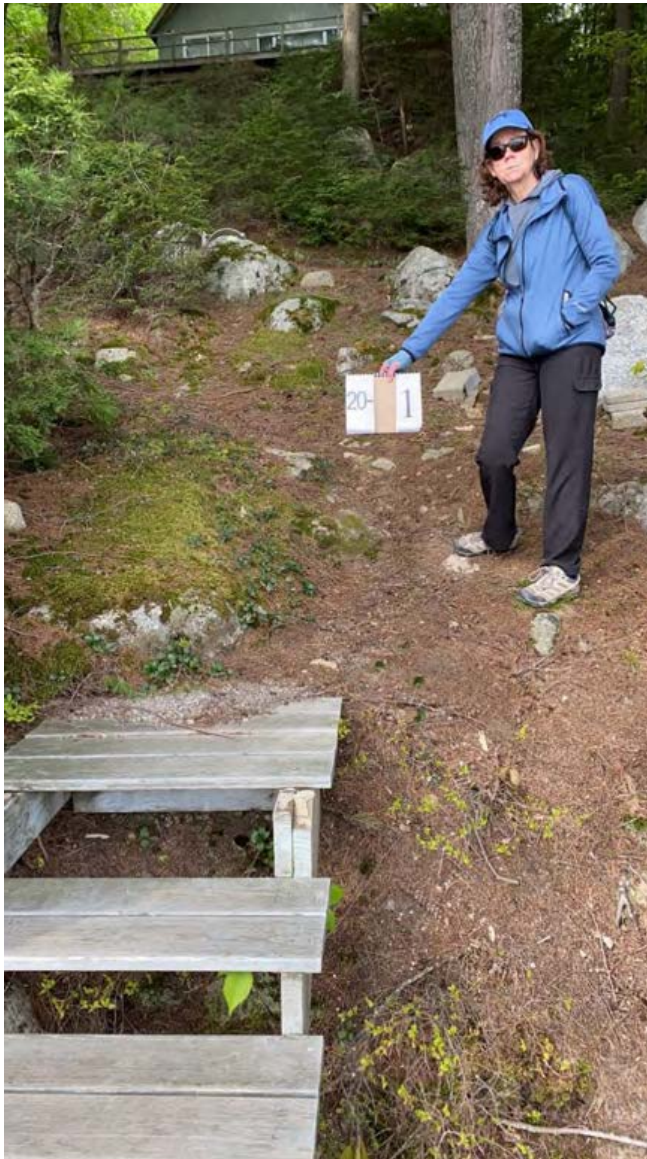
Site 20-01: A low impact trail/path site that has identified sheet surface erosion.

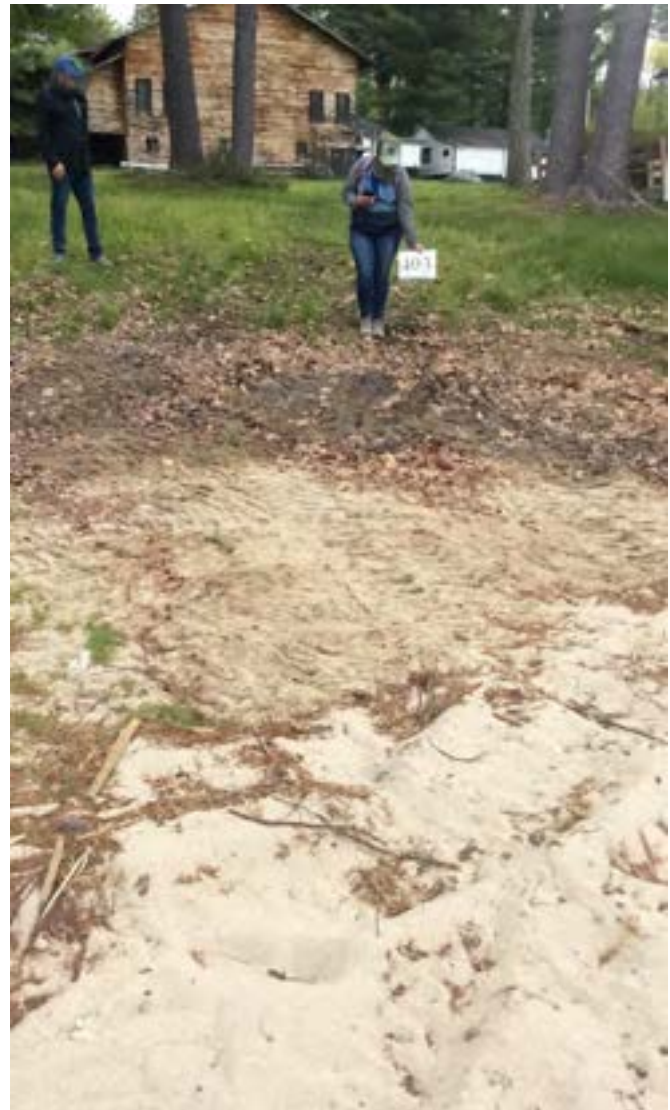
Site 4-03: A high impact commercial site. This site has identified gully surface erosion, shoreline erosion, and inadequate shoreline vegetation as primary problems.

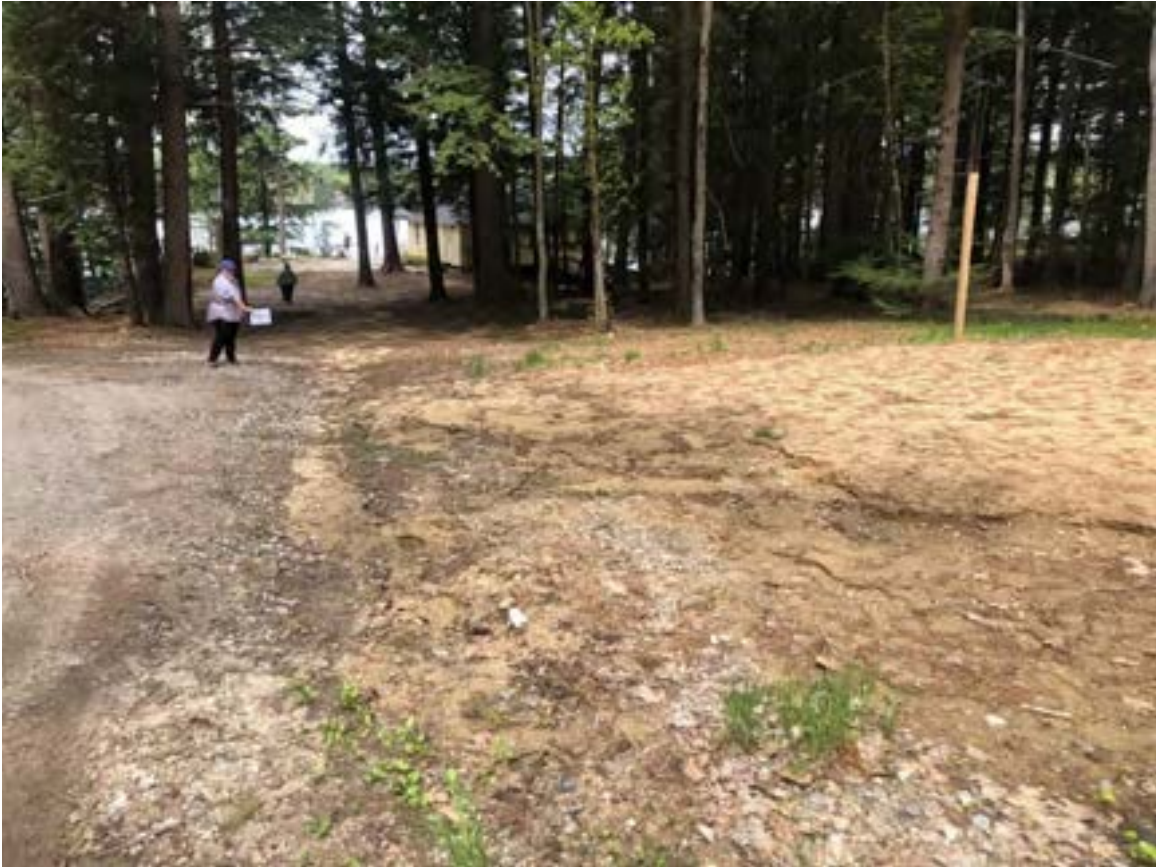
Site 7-03: A medium impact 'other' site that has identified gully sheet erosion at a volleyball court in Sector 7

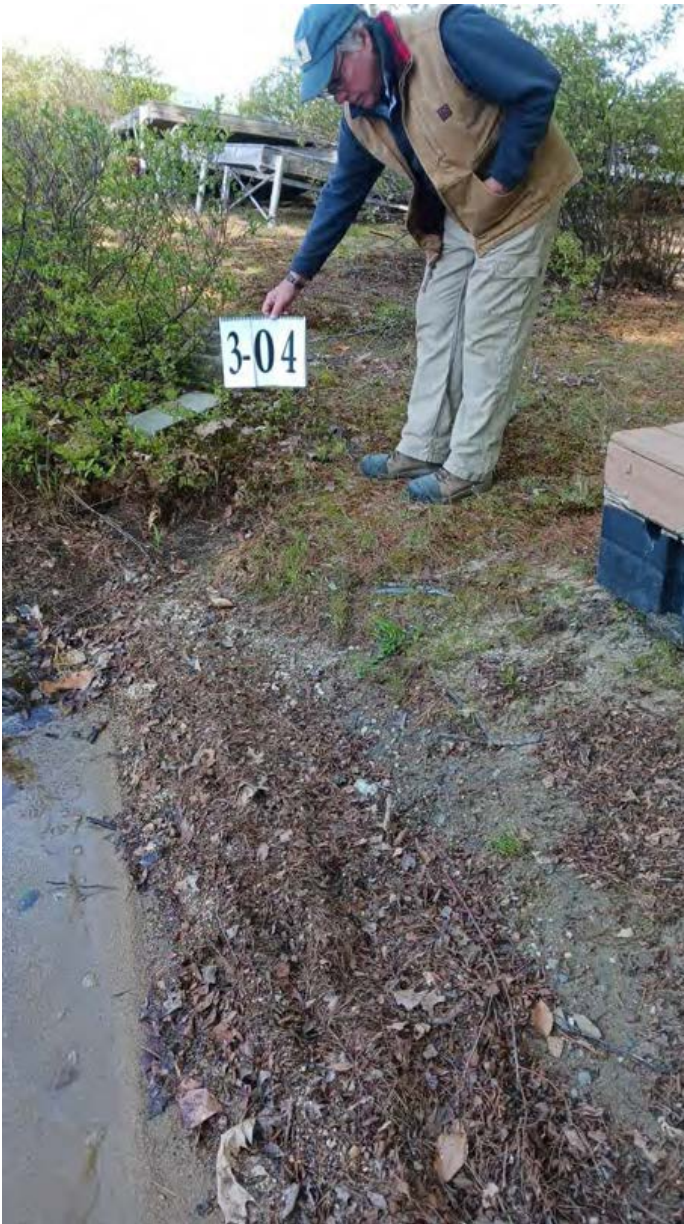
Site 3-04: Low impact residential site.

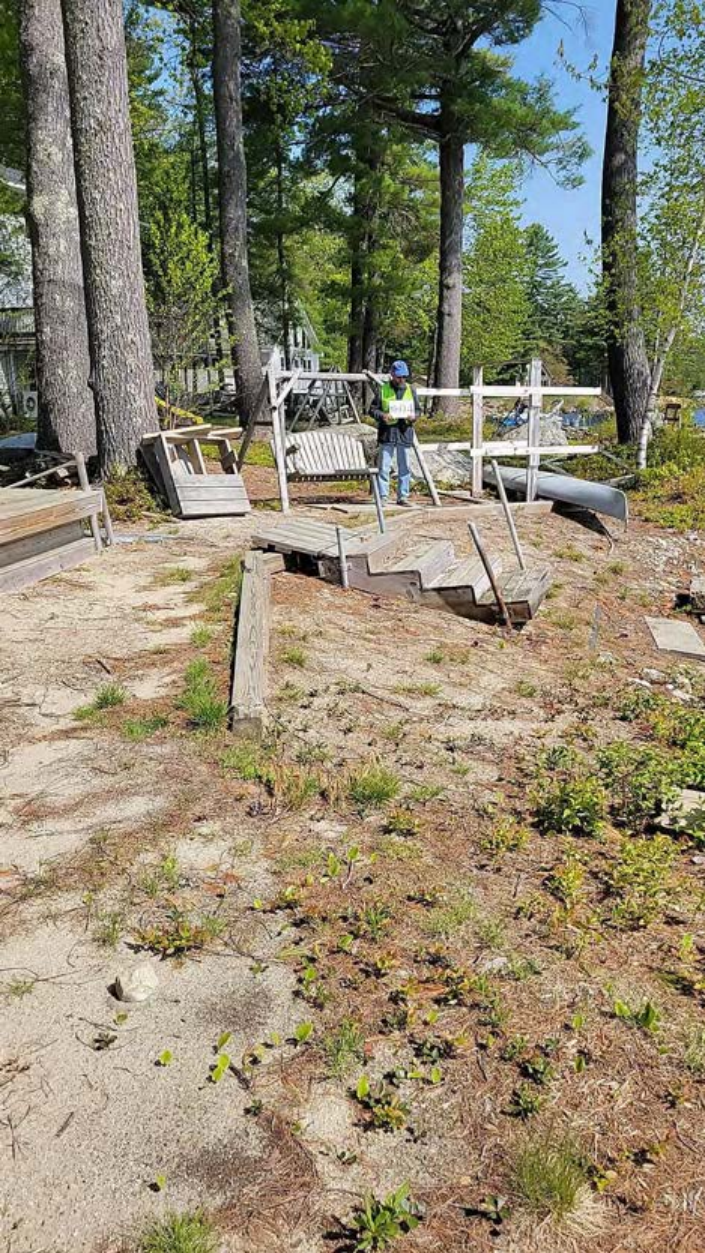
Site 3-04: Low impact beach access site.

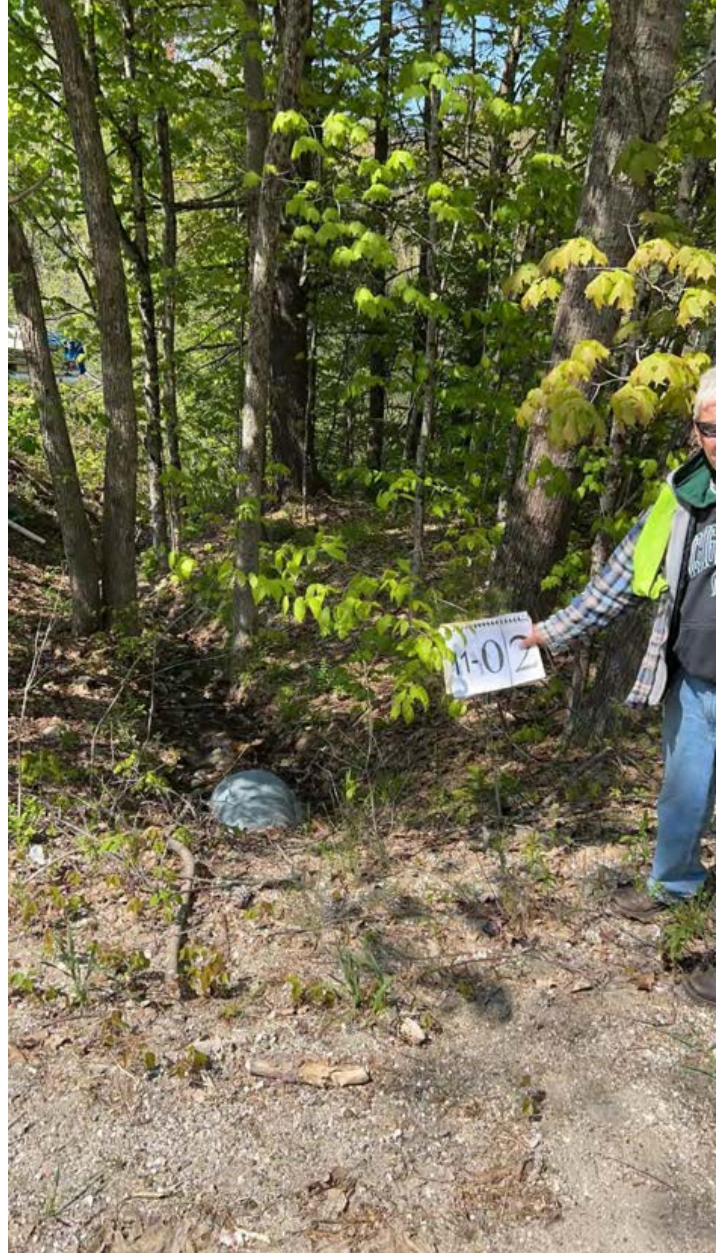
Site 11-02: Low impact town road site.

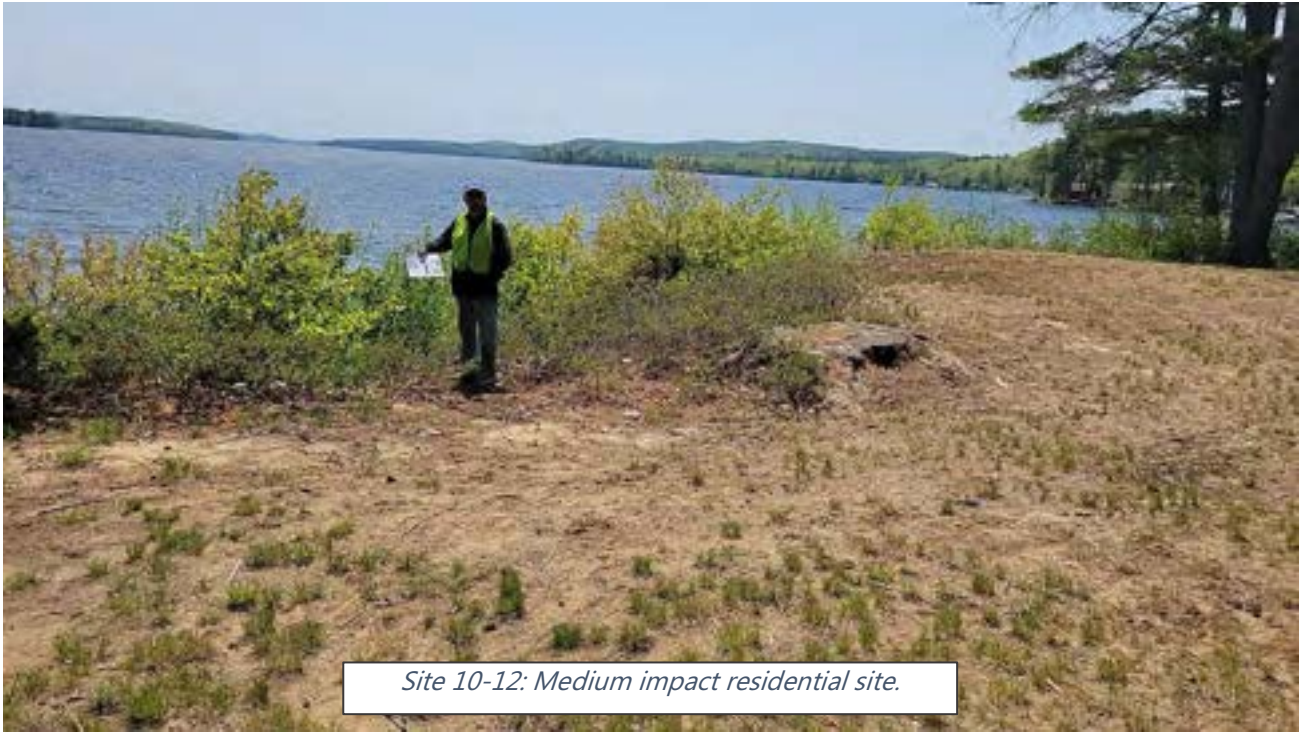
Site 10-12: Medium impact residential site.

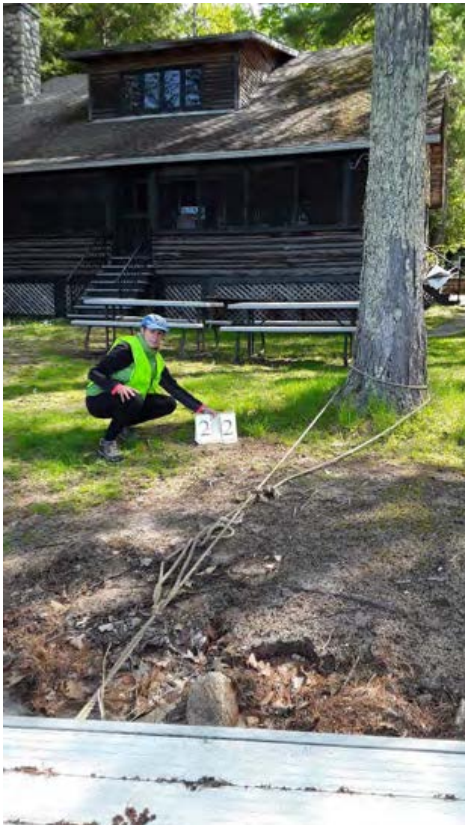
Site 2-02: Medium impact beach access site.

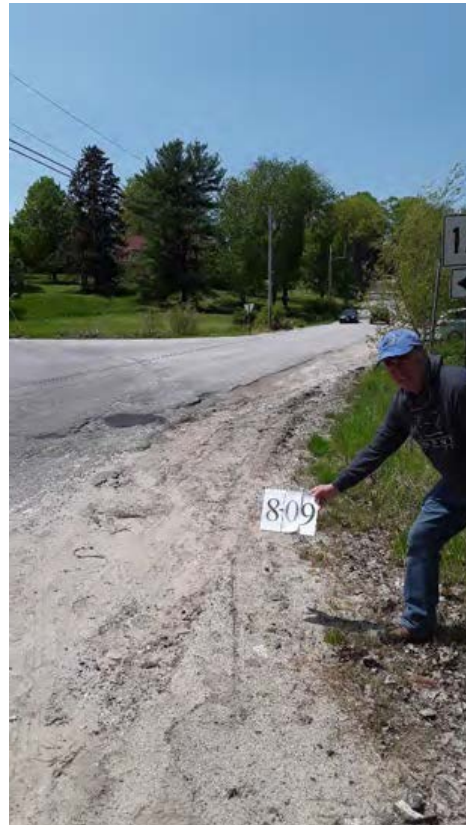
Site 8-09: Medium impact town road site.

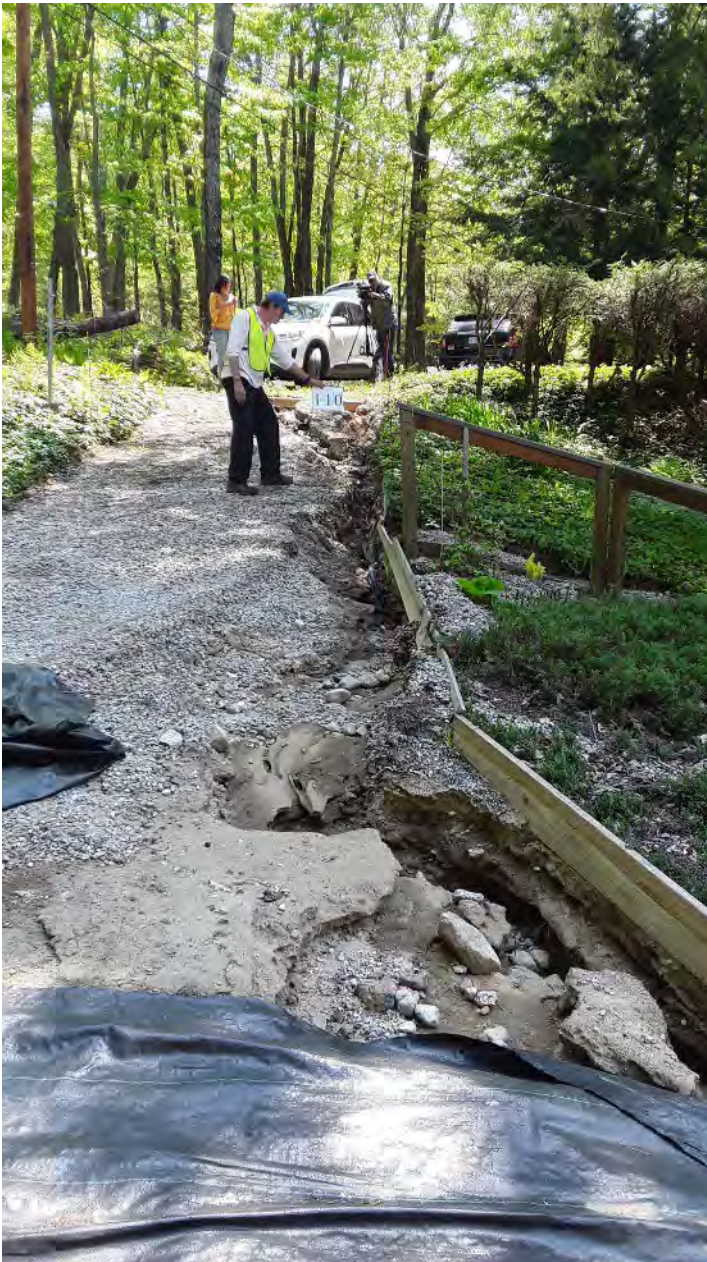
Site 1-10: High impact residential site. Large area experiencing gully erosion flowing directly into the lake without a buffer.

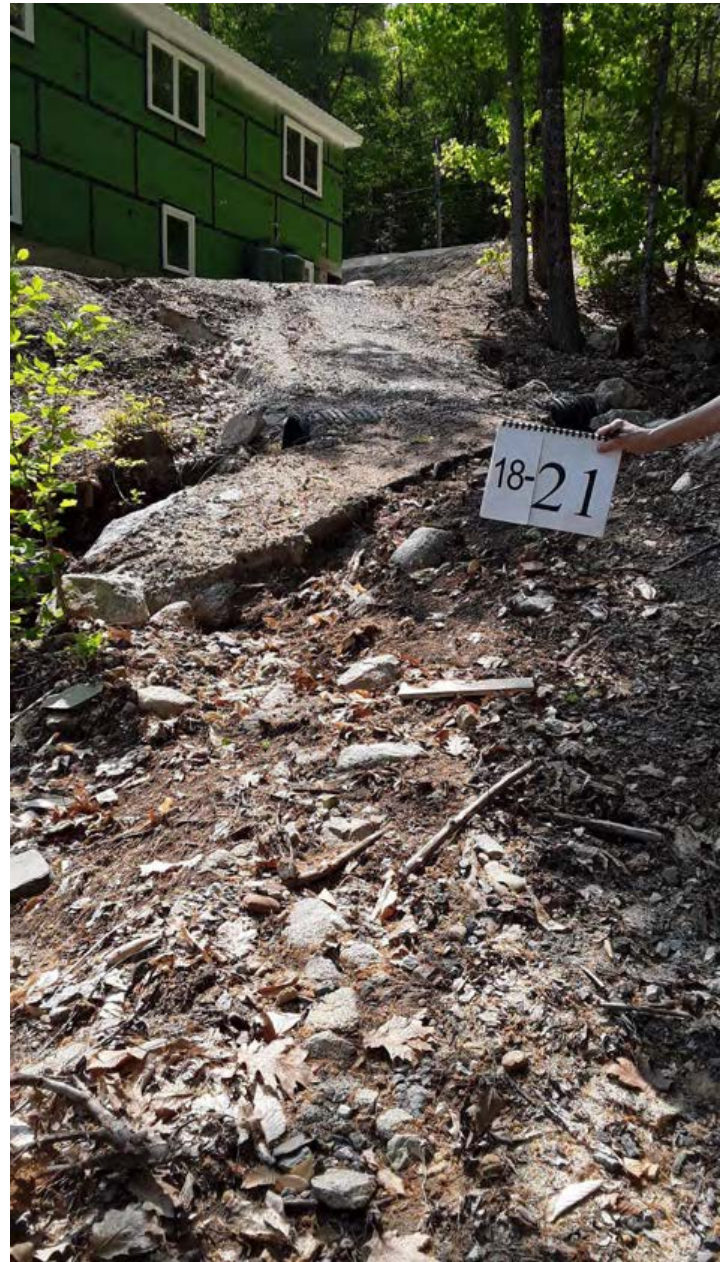
Site 18-21: High impact residential site. Few erosion and sediment controls for active construction on site.

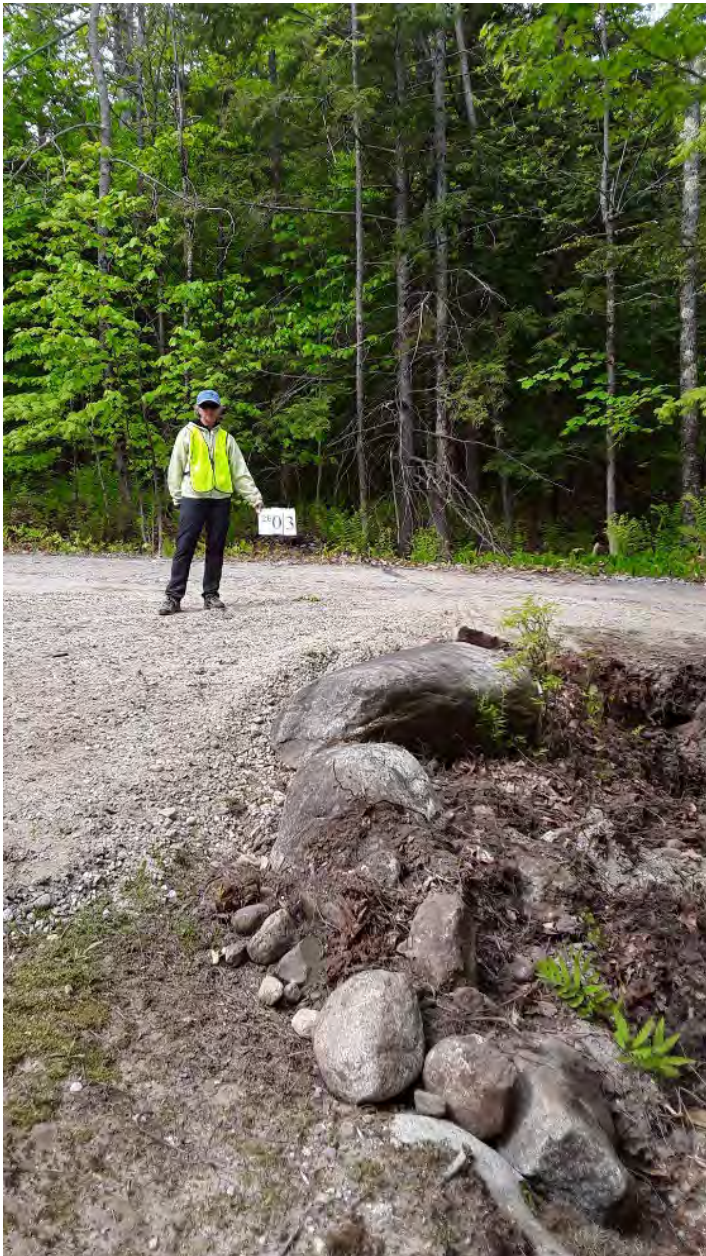
Site 26-03: High impact private road site.

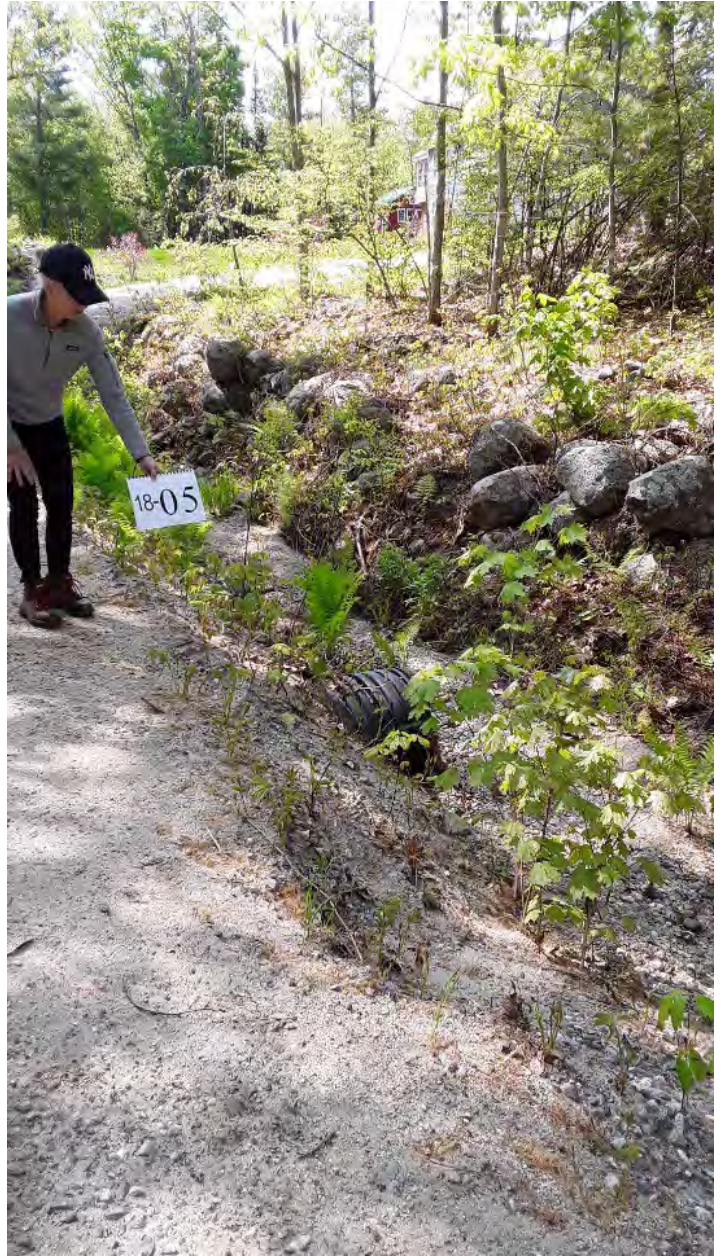
Site 18-05: High impact town road site.
