Youth Conservation Corps

Final Report 2014

Thompson Lake Environmental Association

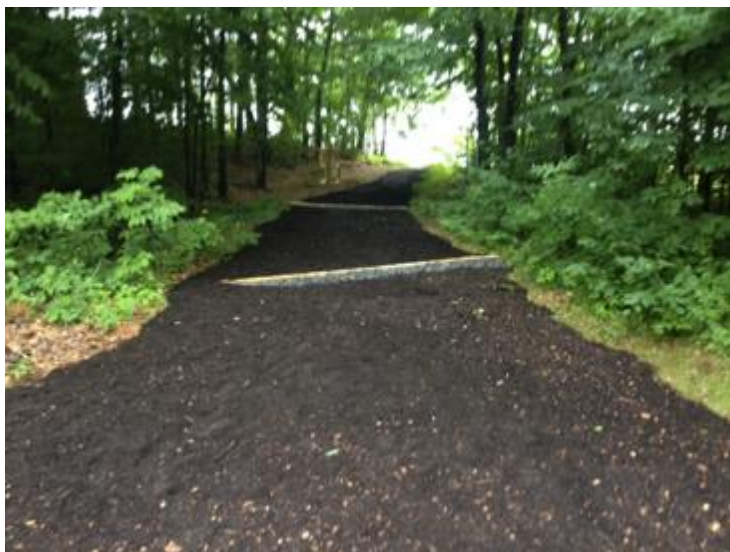
**Thompson Lake Shores Association
Right-of-Way
Thompson Lake Shores Rd.
Casco (319)**

Problem: The right of way for Thompson Lake Shores Association was losing coverage from foot traffic and starting to erode.

Solution: The YCC installed two water-bars and mulched the entire right of way with Erosion control mix. This should divert water off from the pathway and reduce the impact of foot traffic.

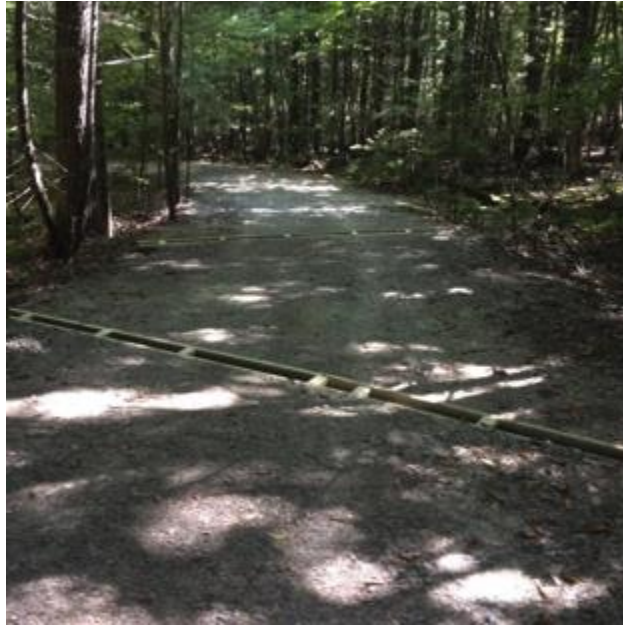
Poland (319)

Problem: This driveway was scouring, creating concentrated channels for water run-off.

Solution: The YCC installed four box-culverts to divert water from the driveway.

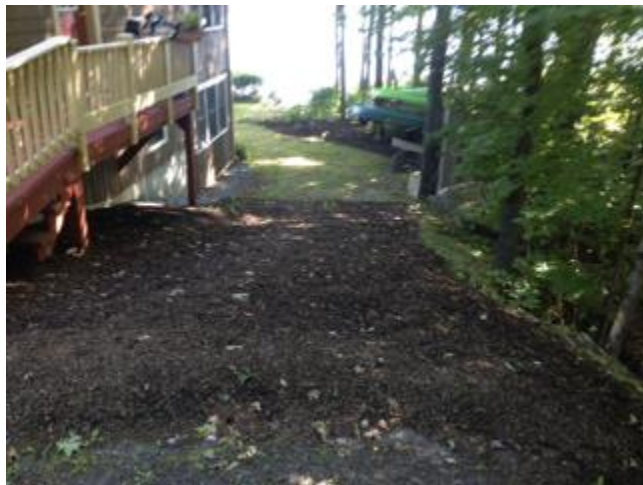
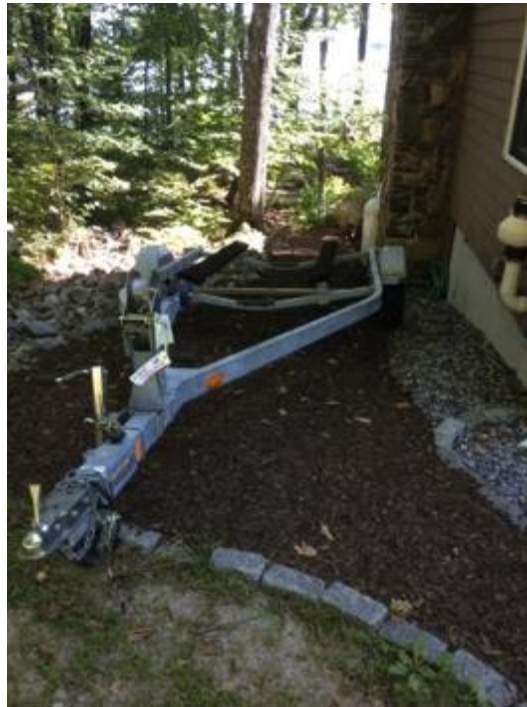
Casco (319)

Problem: This property had a lot of bare area on his property, leaving it vulnerable to erosion.

Solution: The YCC mulched the bare area of his property to reduce the impact of water run-off.

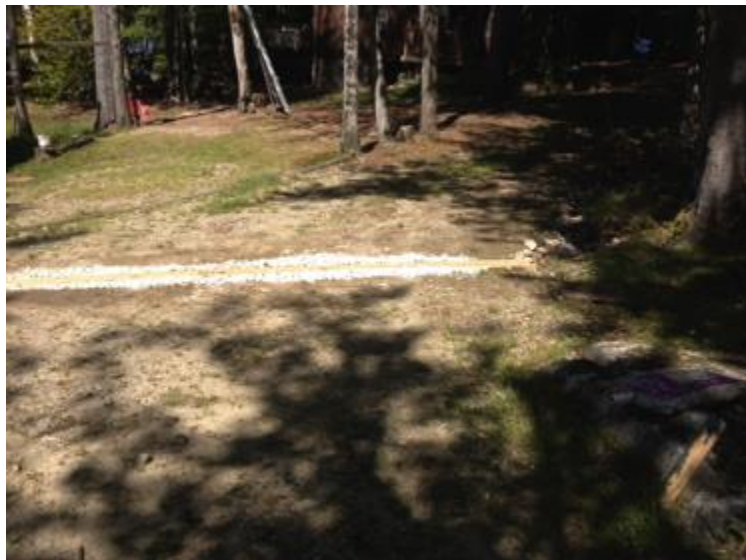
Oxford

Problem: This property has a seasonal run-off channel that runs right through his driveway and underneath his camp.

Solution: The YCC installed a box culvert and two plunge pools to slow down the run-off.

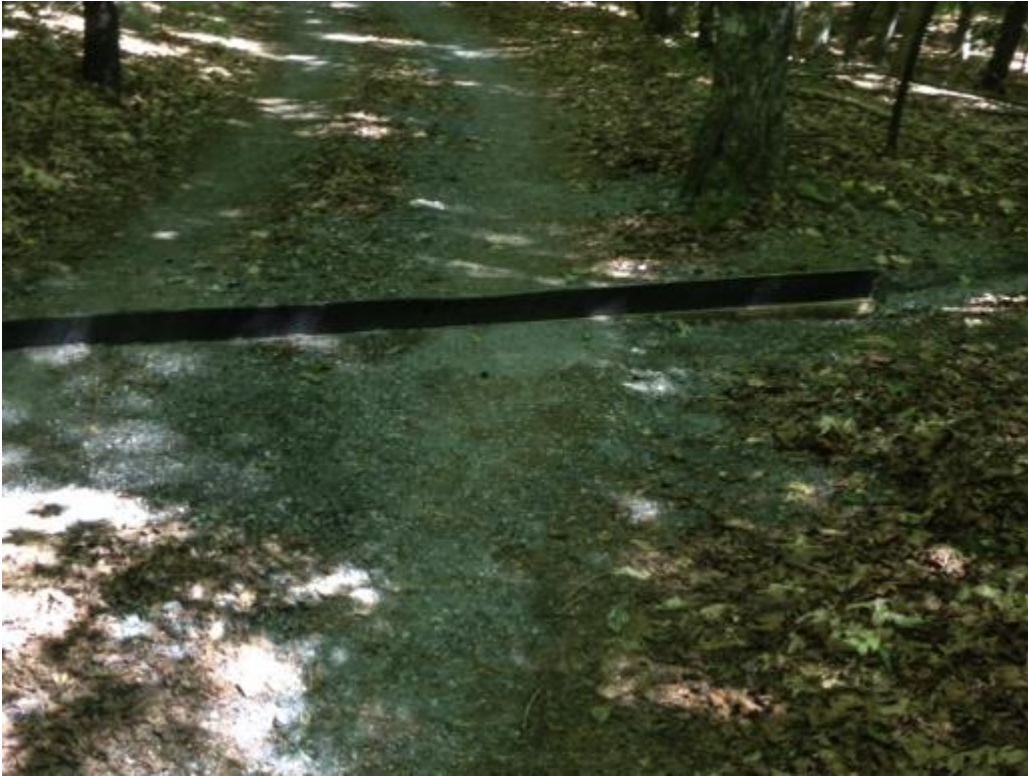
Otisfield

Problem: A razor bar in this driveway had ripped.

Solution: After a handful of razor bar failures over the last few years the YCC decided to try a new fabric reinforced rubber. Replace the rubber in this razor.

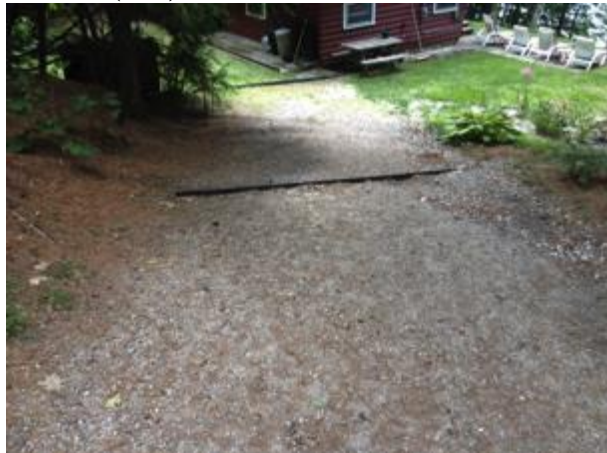
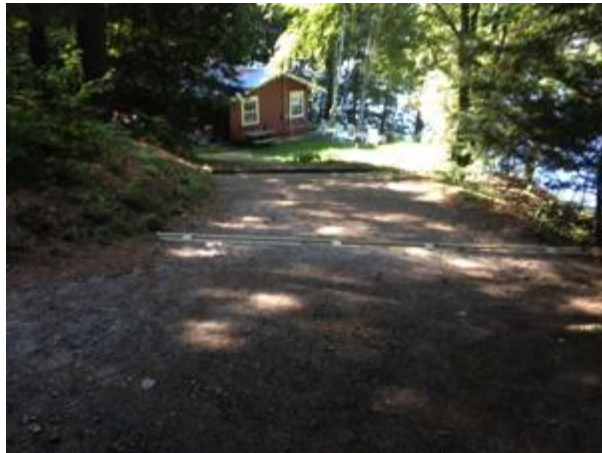
Poland (319)

Problem: These water diverters were no longer doing the job. Leading to erosion in the driveway and down the pathway to the lake.

Solution: the YCC took out the defective water diverters and put in a new box culvert and a new razor bar.

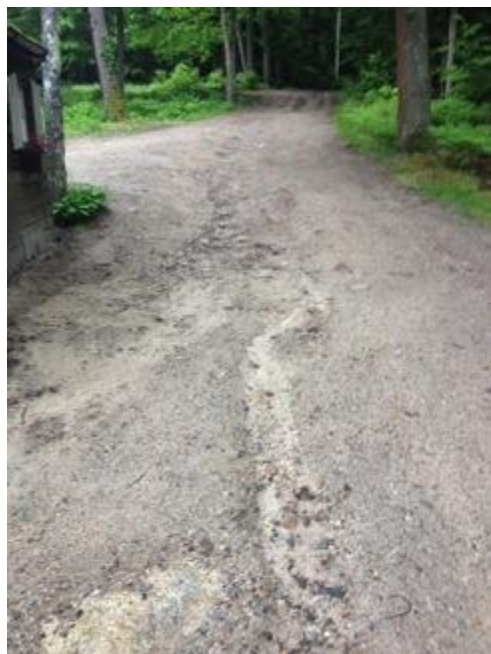
West Poland (319)

Problem: This property had severe scouring in the driveway and a shoreline that we undercut.
Solution: The YCC resurfaced their driveway with 3/4" crushed gravel and installed three box culverts to divert the water. On the shoreline the YCC hand placed rip-rap where there was undercutting.
