Subject: Inspection of Thompson Lake Dam

The Thompson Lake Dam (Maine ID 00133, NatDam ID ME00016) is located at the outlet of Thompson Lake, on Outlet Stream, a tributary of the Little Androscoggin River, in the Town of Oxford (Town), Cumberland County, Maine (Figure 1). The dam was originally installed around 1800, rebuilt in 1863 and modified in 1974. The 1863 dam reportedly raised the natural lake level by 10 feet. Since 1863 the dam was owned by the Robinson Manufacturing Co. The Robinson woolen textile mill was closed in 2004 and the dam ownership was transferred to the Town of Oxford in 2009. The dam has low hazard classification.

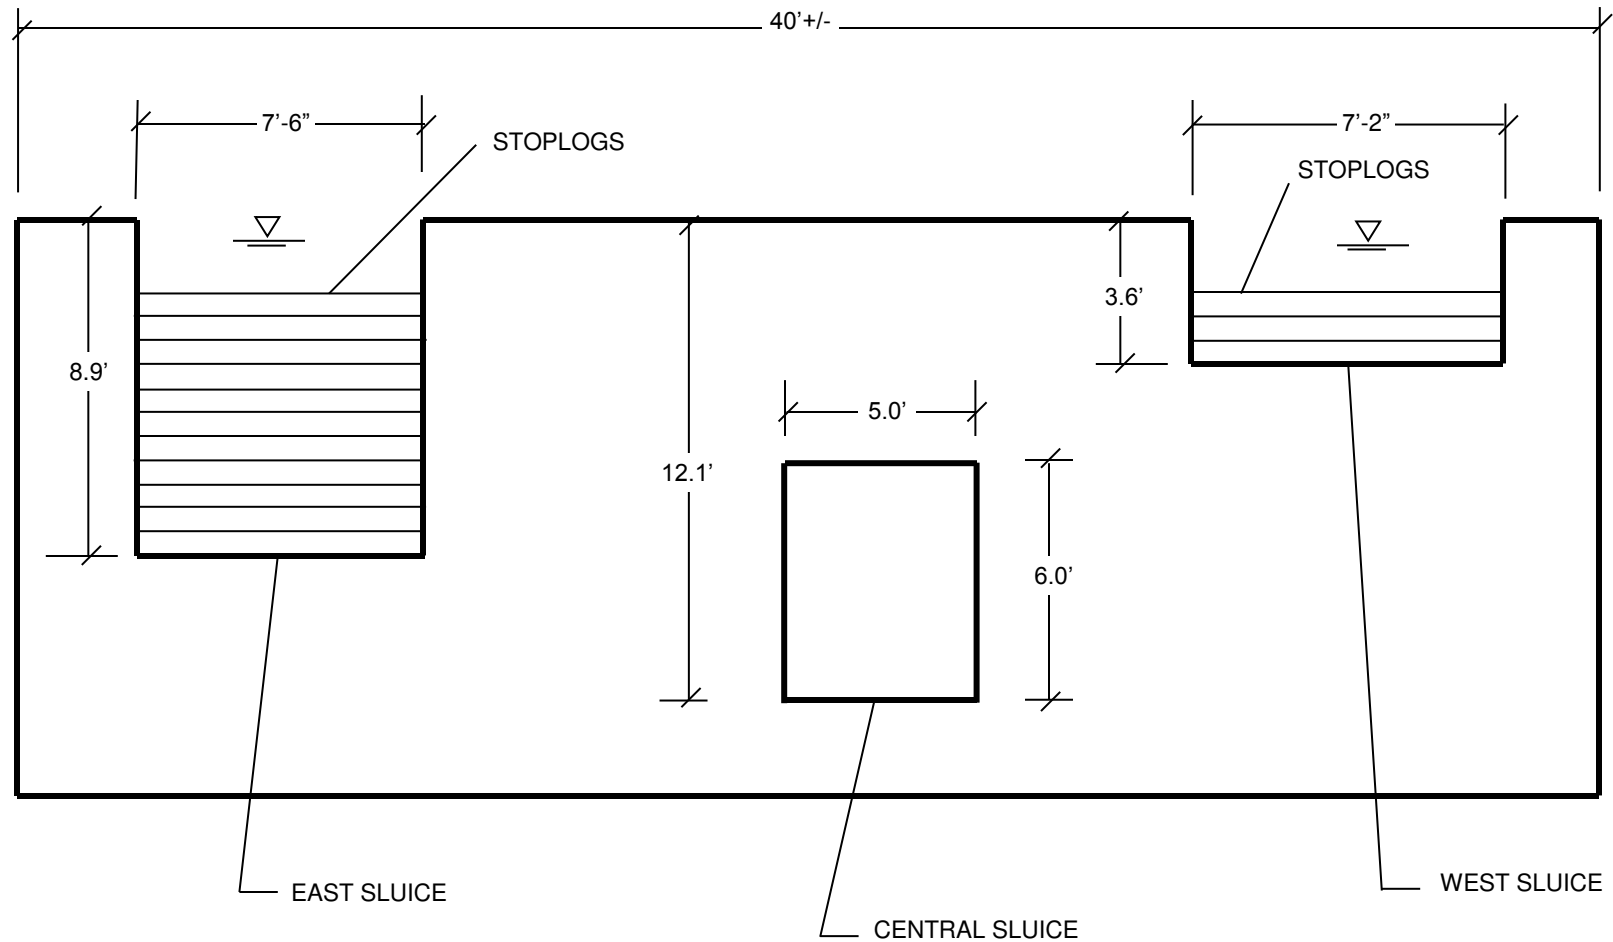
**FIGURE 3. DOWNSTREAM ELEVATION OF MASONRY DAM SECTION: GENERAL ARRANGEMENT.**

Dam Hydraulics. During the field inspection, the size of the dam water conveyance facilities (the central gate sluice and east and west stoplog sluices) and their sill elevations (depth) from the top of the dam were measured. The results of the sluice dimension measurements are included in Figure 3. The maximum discharge capacity of each sluice was calculated with the pond level at
